EXISTING CONDITION & FEASIBILITY STUDY

**50 PIERMONT AVENUE
NYACK, NY 10960**

September 20, 2024

DRP PROJECT NO

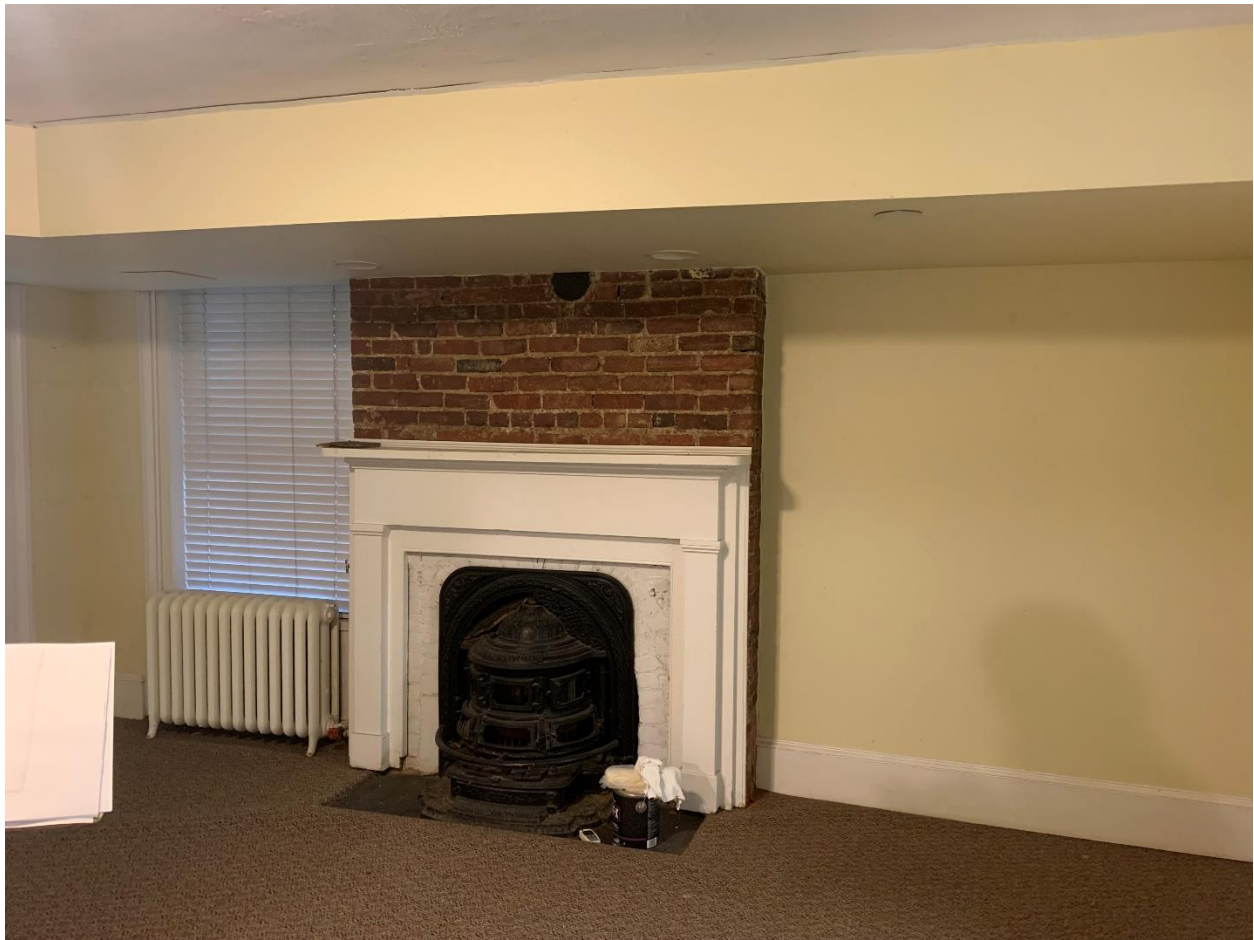
Figure 1. Basement - Drywall separation at ceiling between finishes located at basement level.

- **Basement Floor finishes:**
 - Wall and ceiling gypsum board finishes should be restored at the areas of plumbing repair work and as needed at any probes which are performed.
 - Separated drywall taping at seams of unit L1 should be removed and replaced. Area should be taped, spackled and painted to match existing.
- **1st Floor Finishes:**
 - Sagging portion of plaster ceiling shall be re-secured to wood lath ceiling with washers to arrest any further movement and compound applied to match existing ceiling finish upon completion of repair.

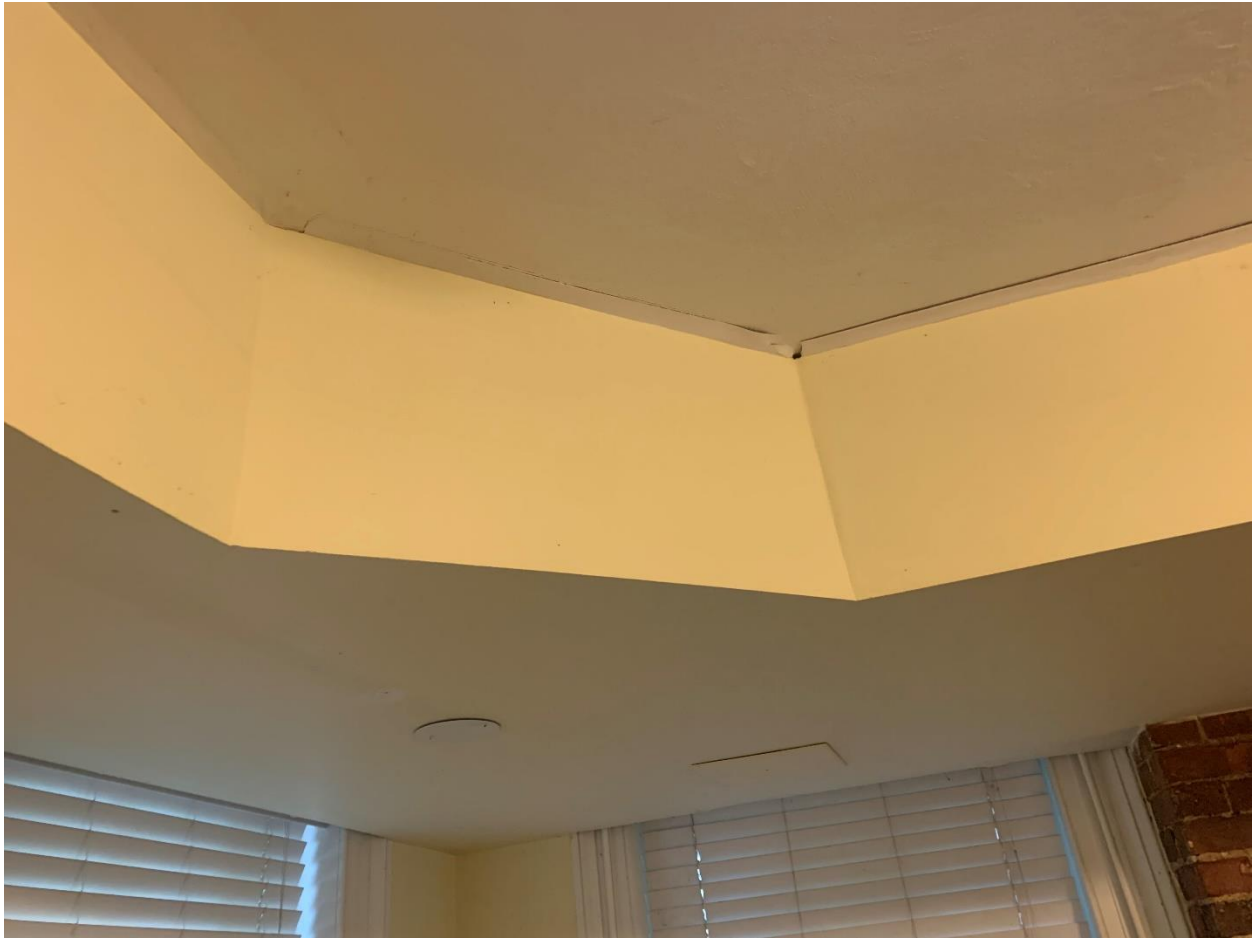
Figure 2. Basement Drywall Separation at ceiling near corner of room located at basement level.

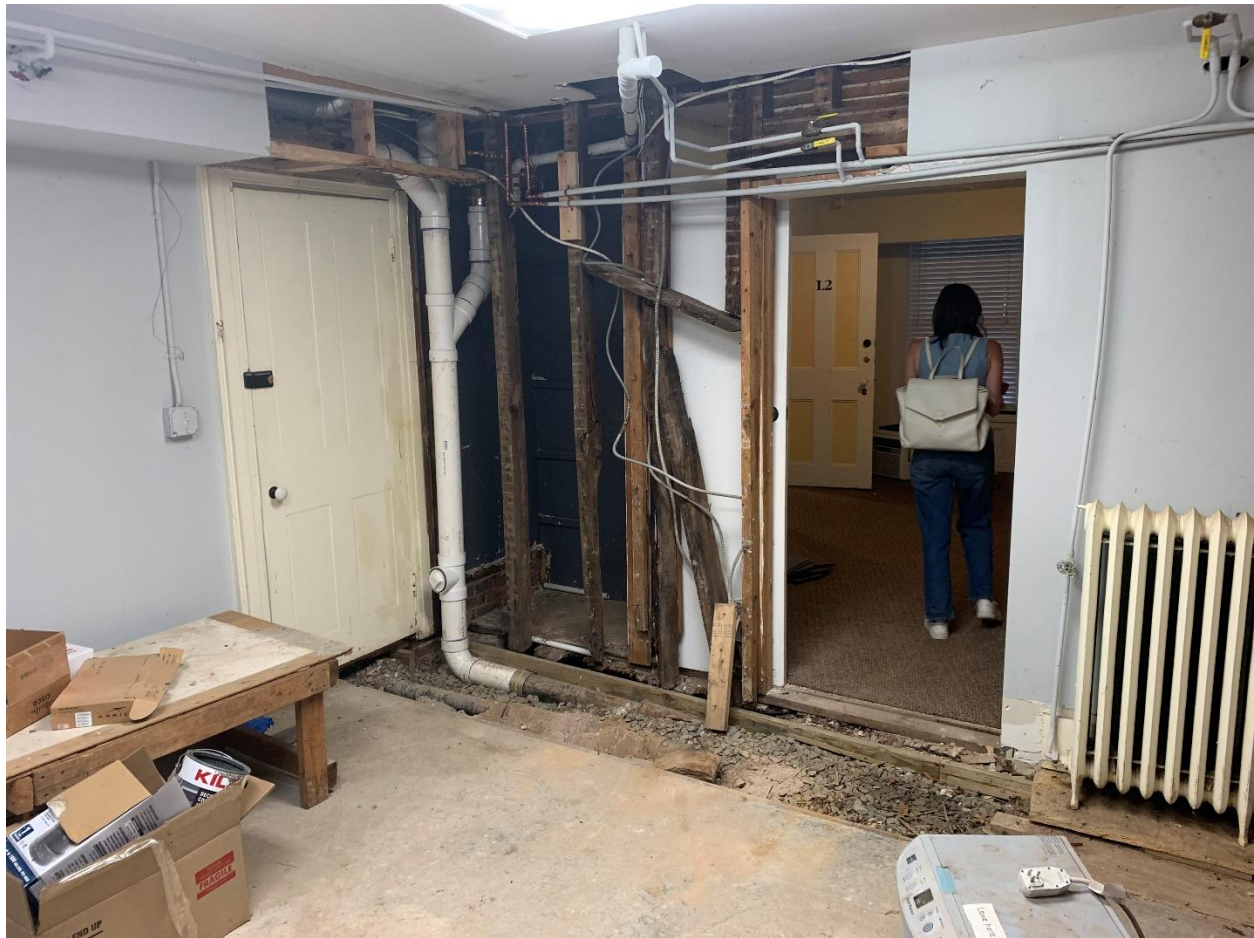
Figure 3. Basement- Condition of interior partition wall adjacent to plumbing work

- **Basement floor:**
 - Probes of the framed portion of the basement floor level should be performed to confirm the condition of the framing at the front half of the building. Probes should also be performed on the partition wall in L2 on the north side of the building to confirm whether similar deterioration of the framing exists at this interior stud wall.

- The portion of damaged subfloor and the base plate of the stud wall at the damaged partition wall should be removed and rebuilt in kind. All framing in direct contact with soil should be pressure treated.

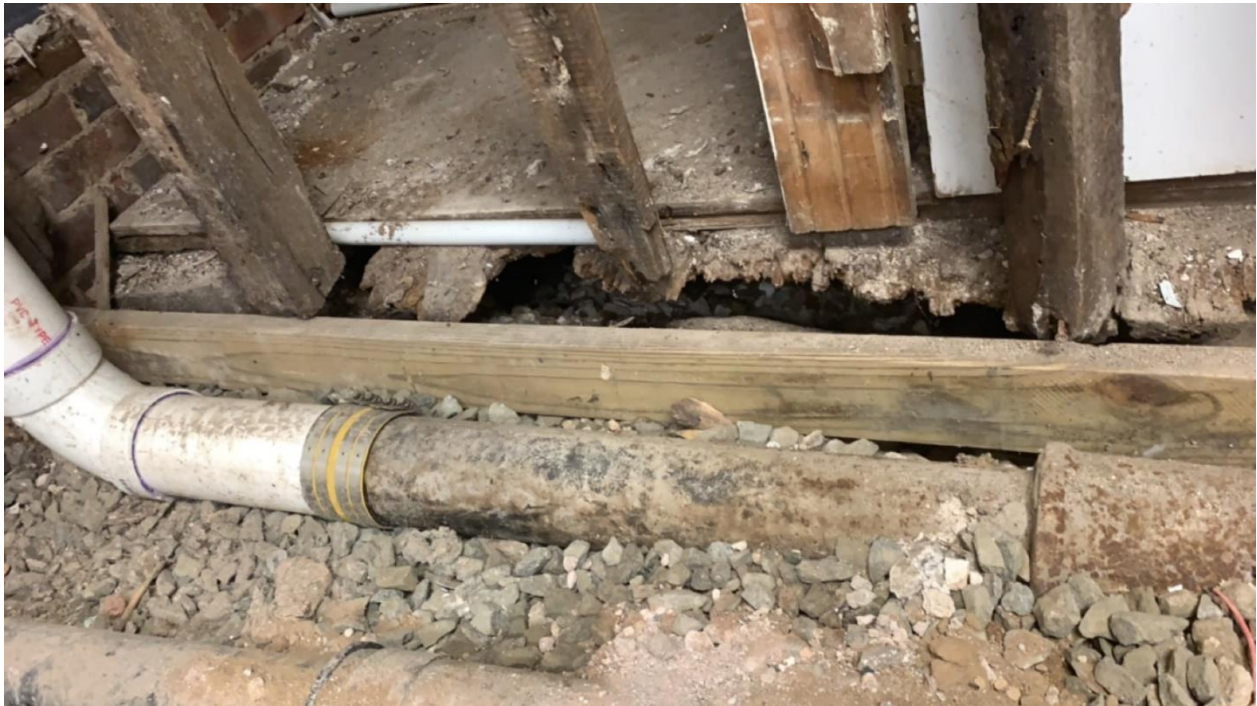
Figure 4. Basement- Condition of base of partition wall

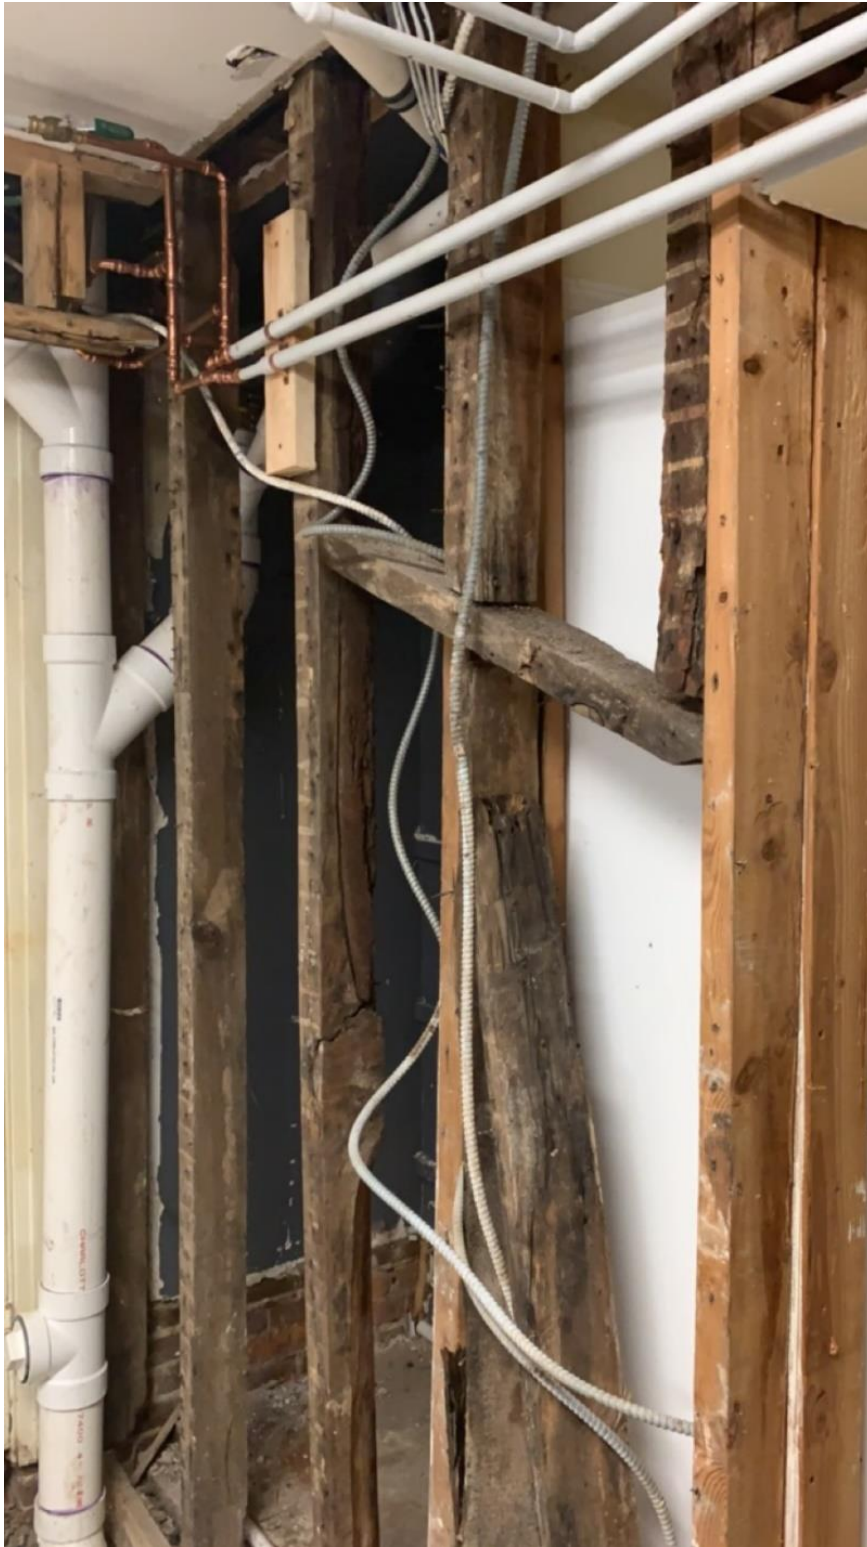
Figure 5. Basement - Condition of exposed stud framing at basement level

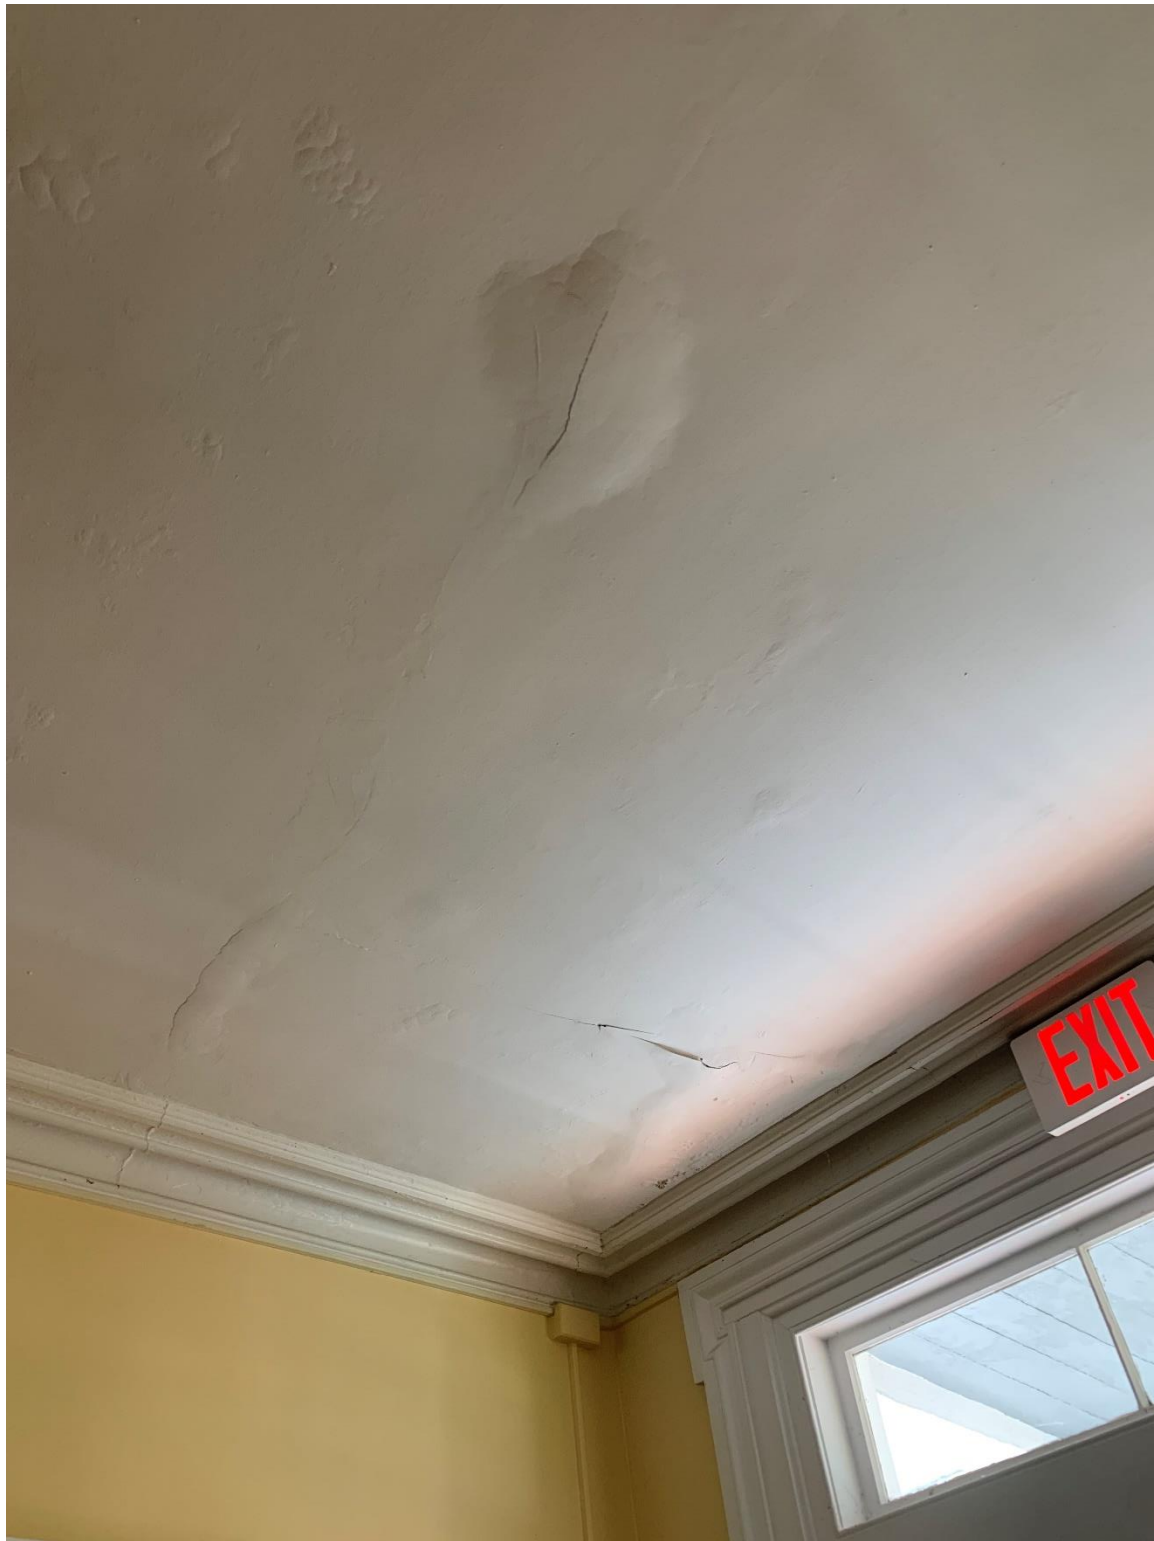
Figure 6. 1st floor hallway - Ceiling Cracks/Water Damage at 1st Floor Rear Entry

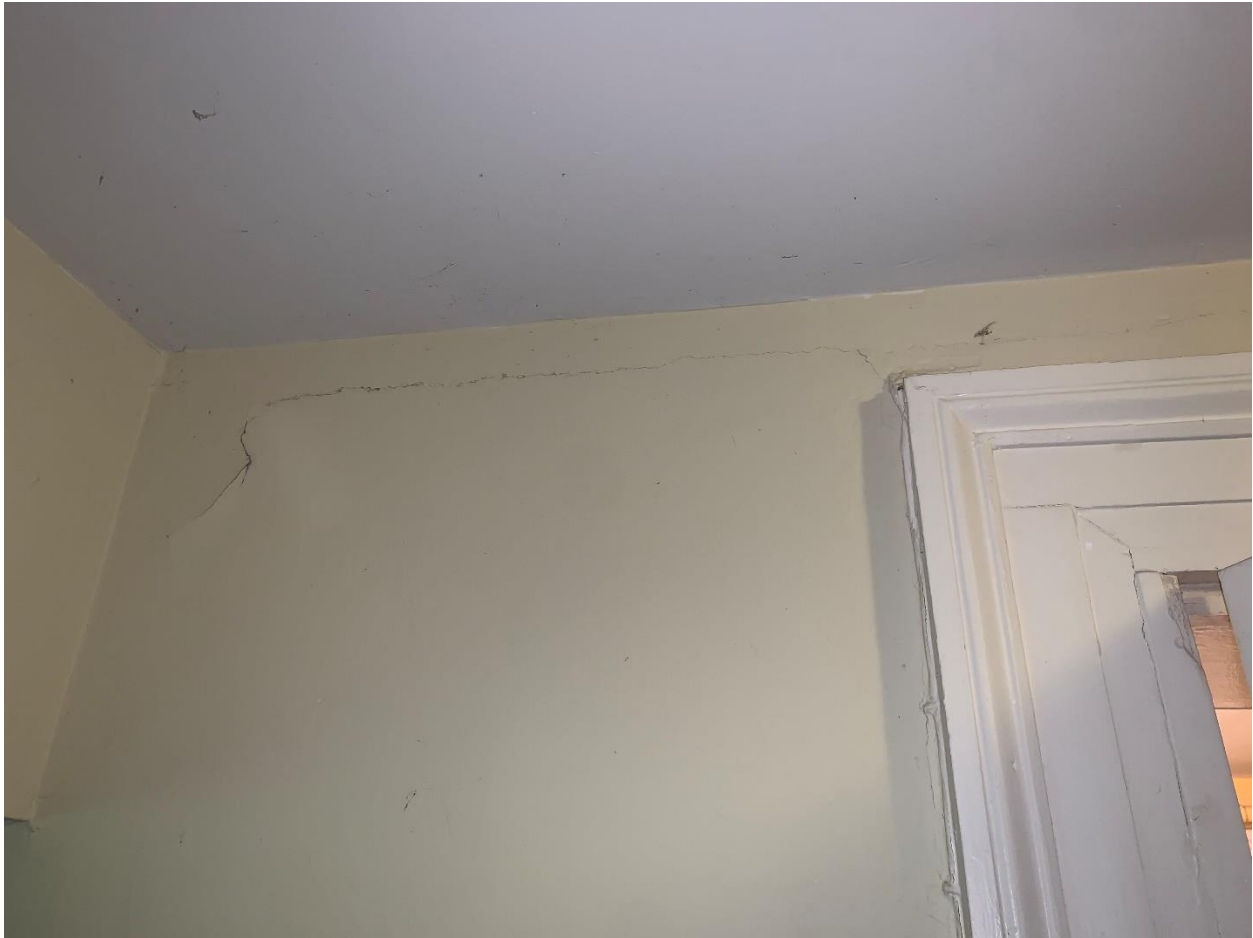
Figure 8. Suite 1B - Cracking at wall starting at the door frame located at the first level.

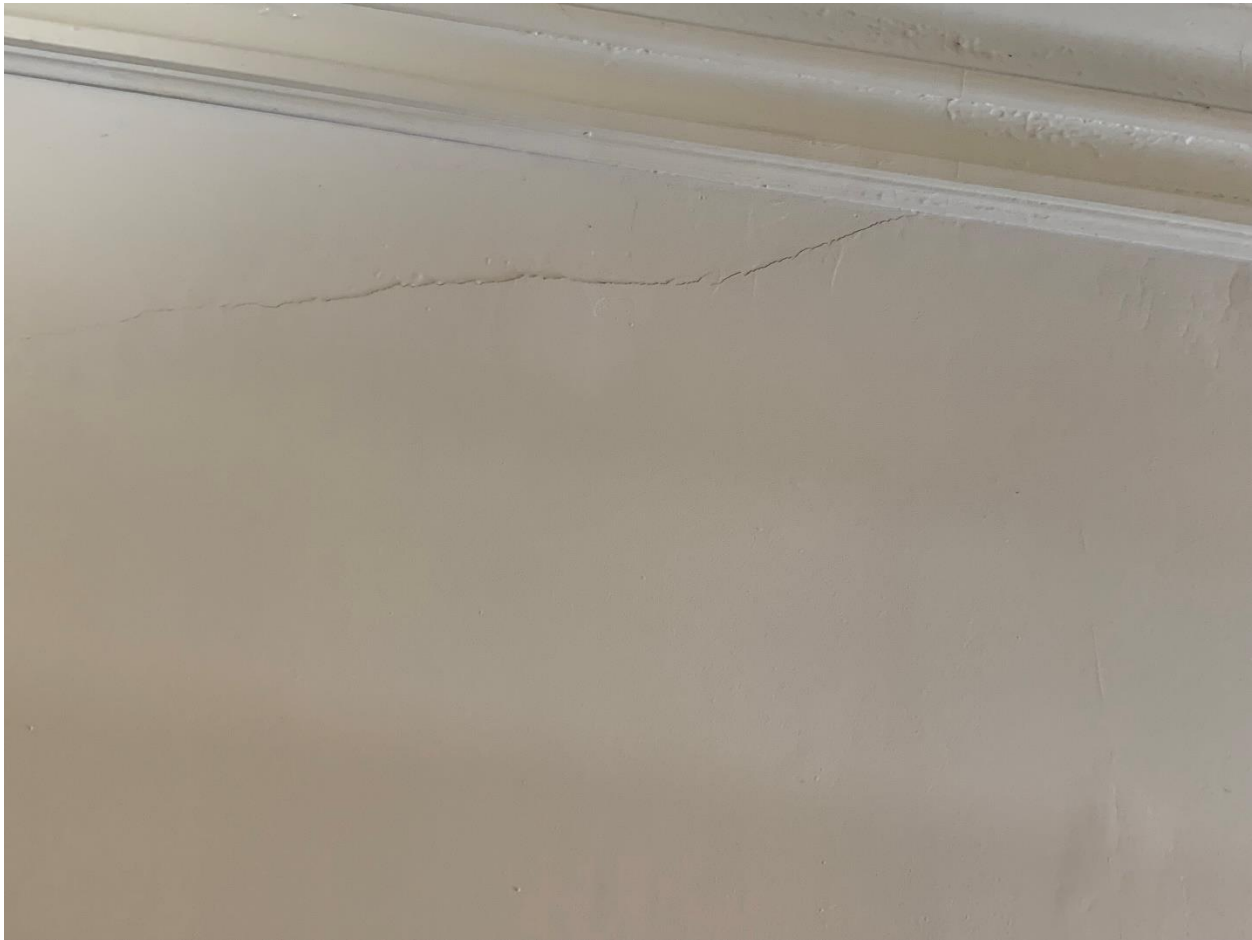
Figure 9. Suite 1B - Cracking at ceiling located at the first level.

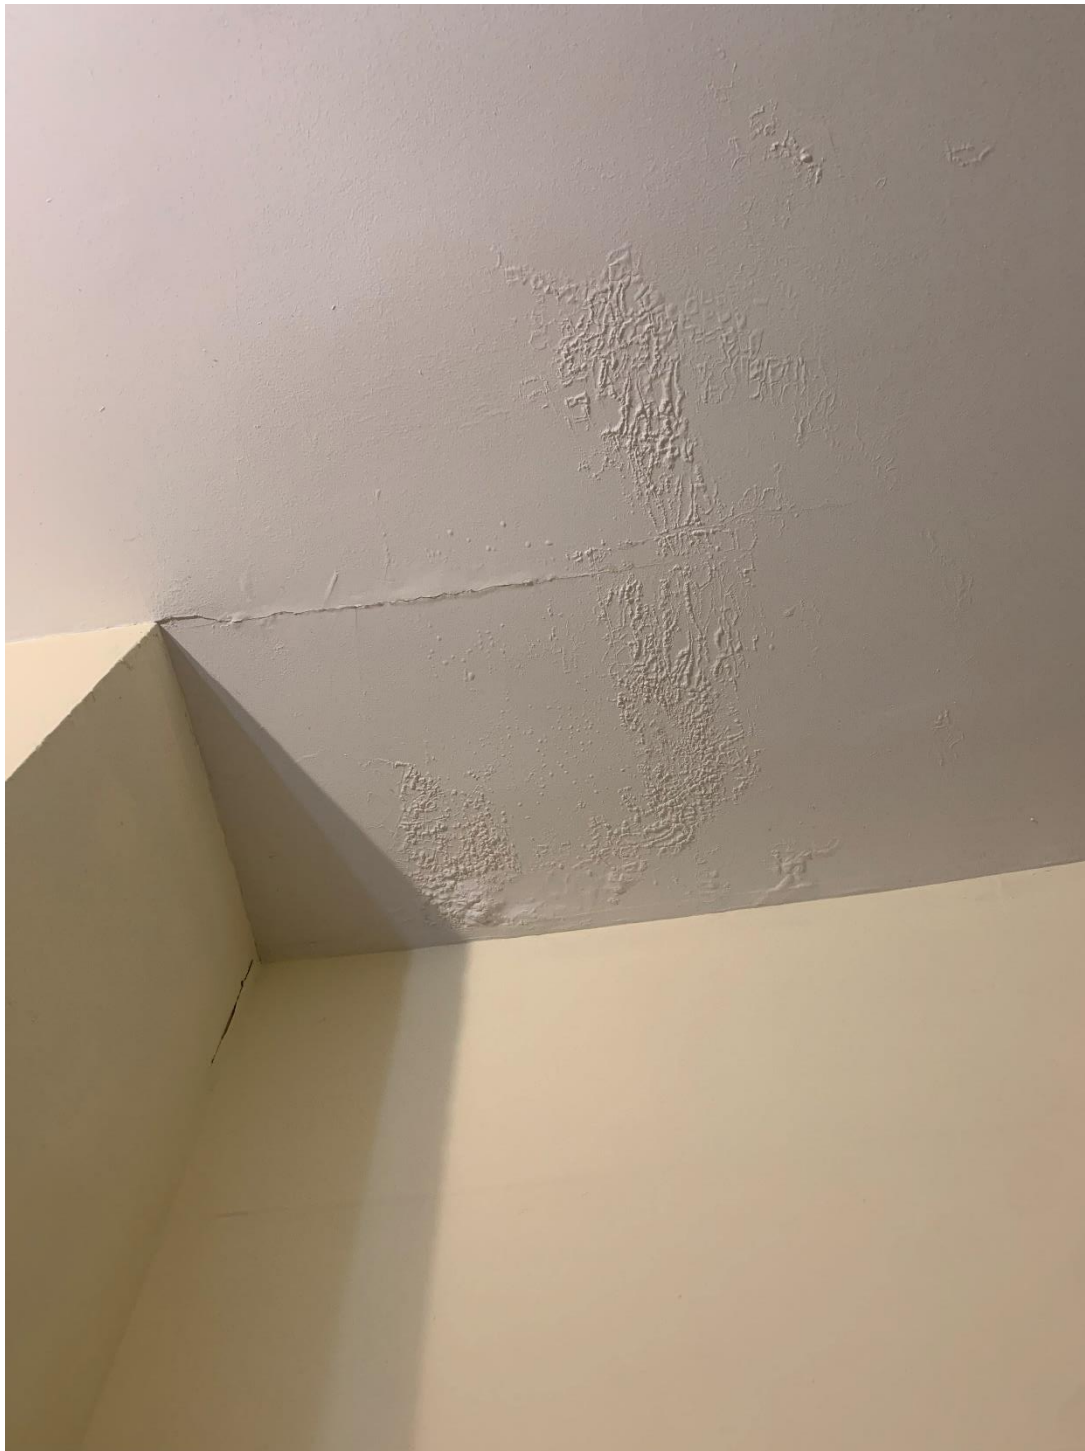
Figure 10. Suite 1B - Water damage at ceiling located at the first level.

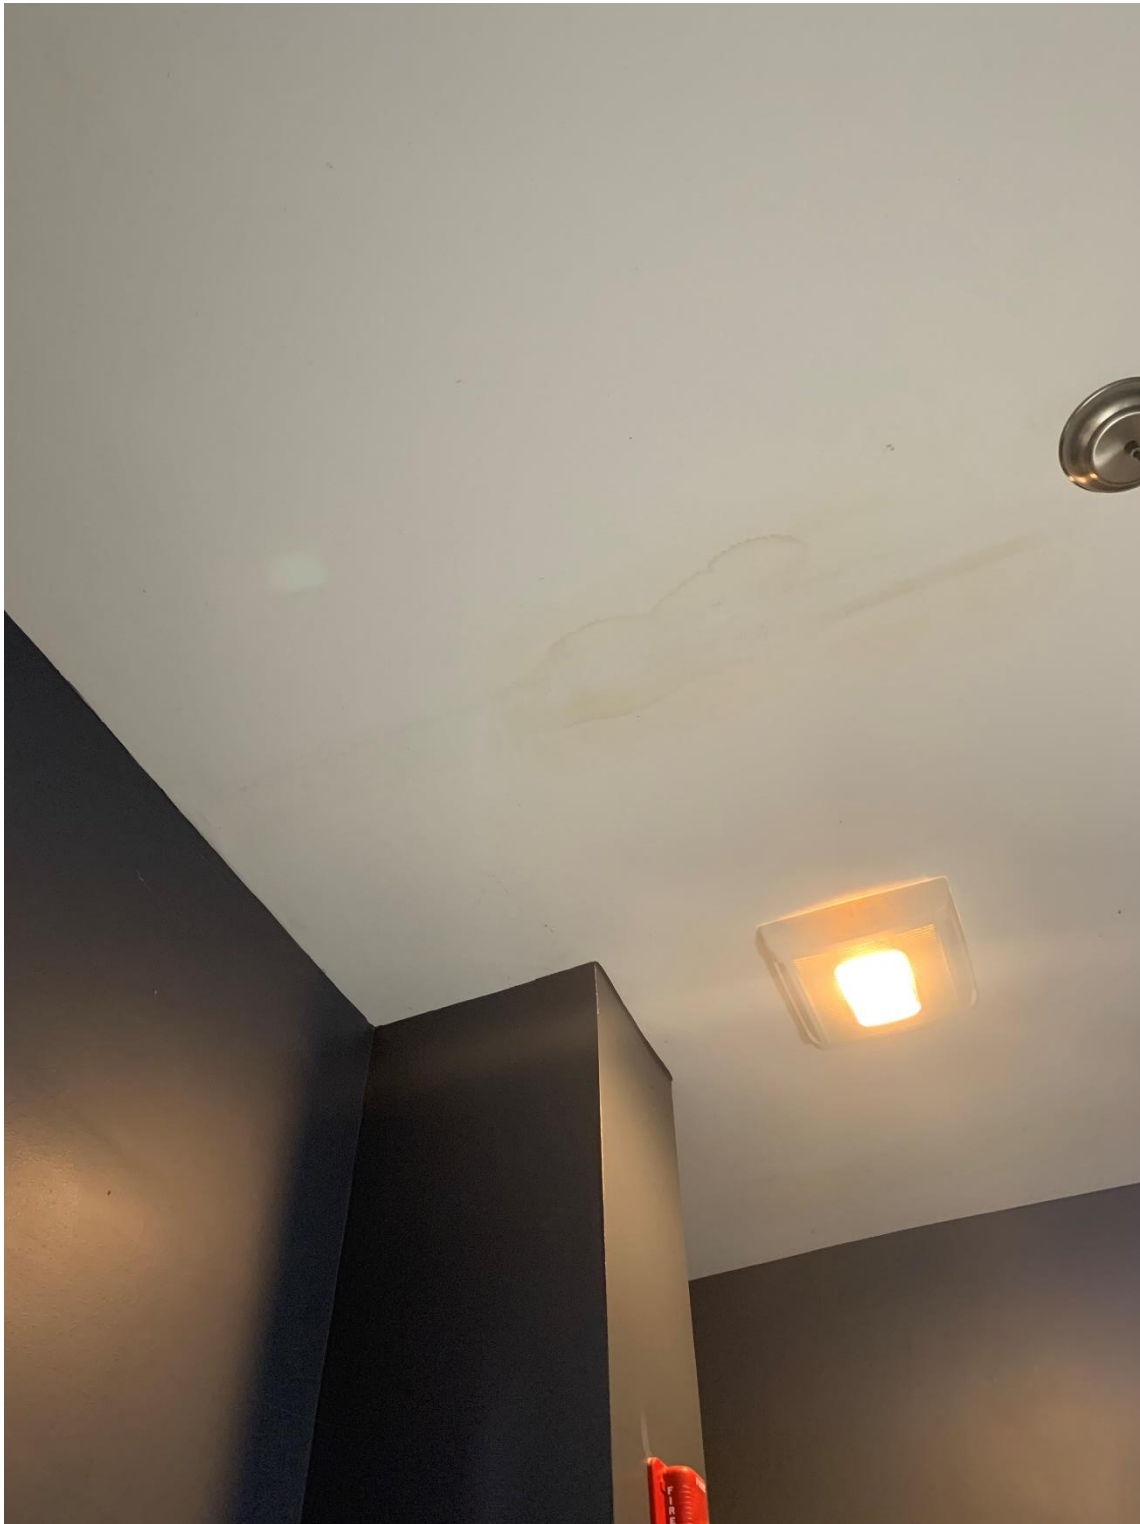
- **1st floor shared bathroom:** The finishes in the 1st floor shared bathroom are in fair condition including wall and floor finishes and plumbing fixtures. The bathroom on this level appears to have been renovated in 2005. Damage from a minor leak was noted on the ceiling finishes (Figure 11).

Figure 11. 1st floor bathroom - Water damage at ceiling

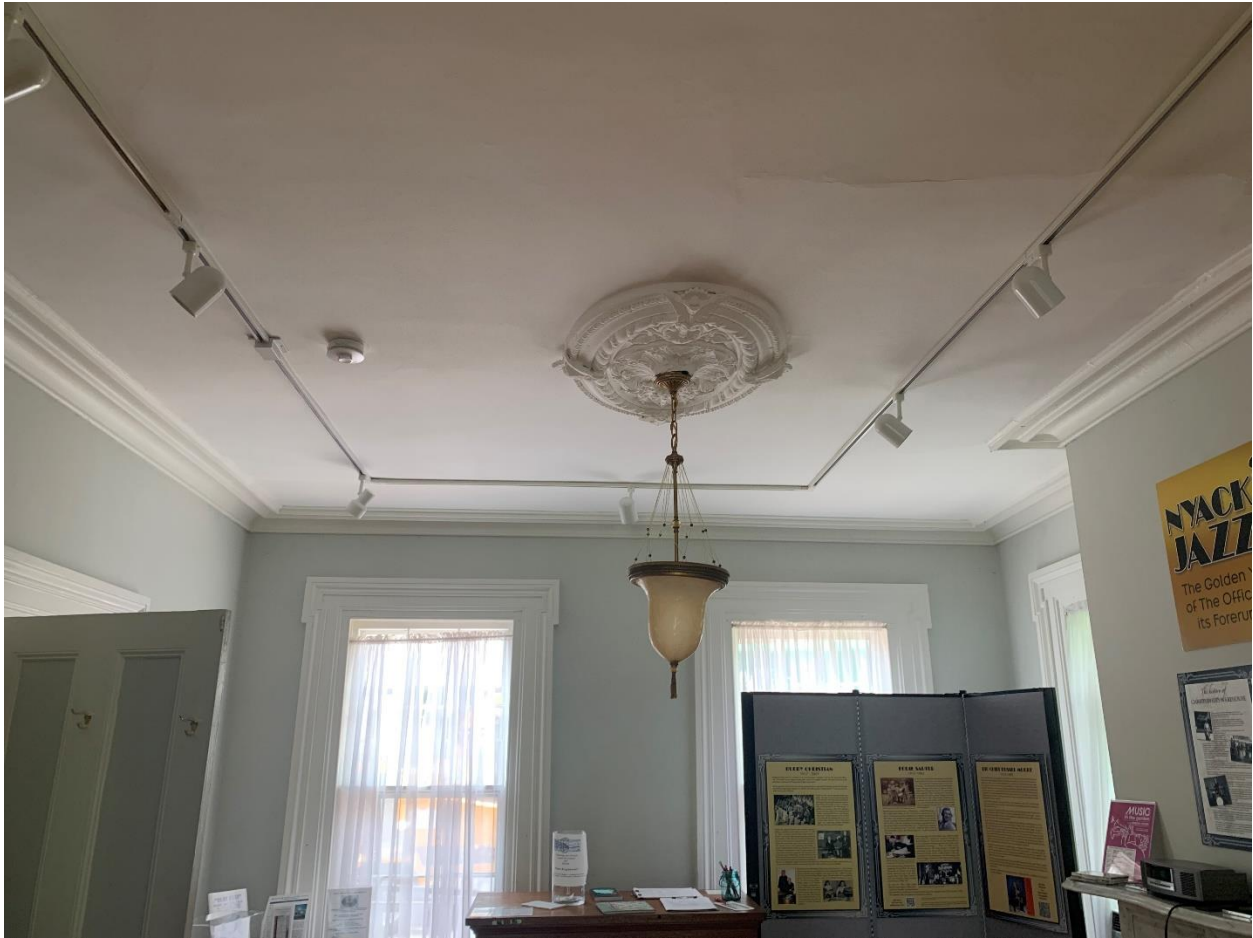
Figure 12. Suite 1A - Cracking at ceiling

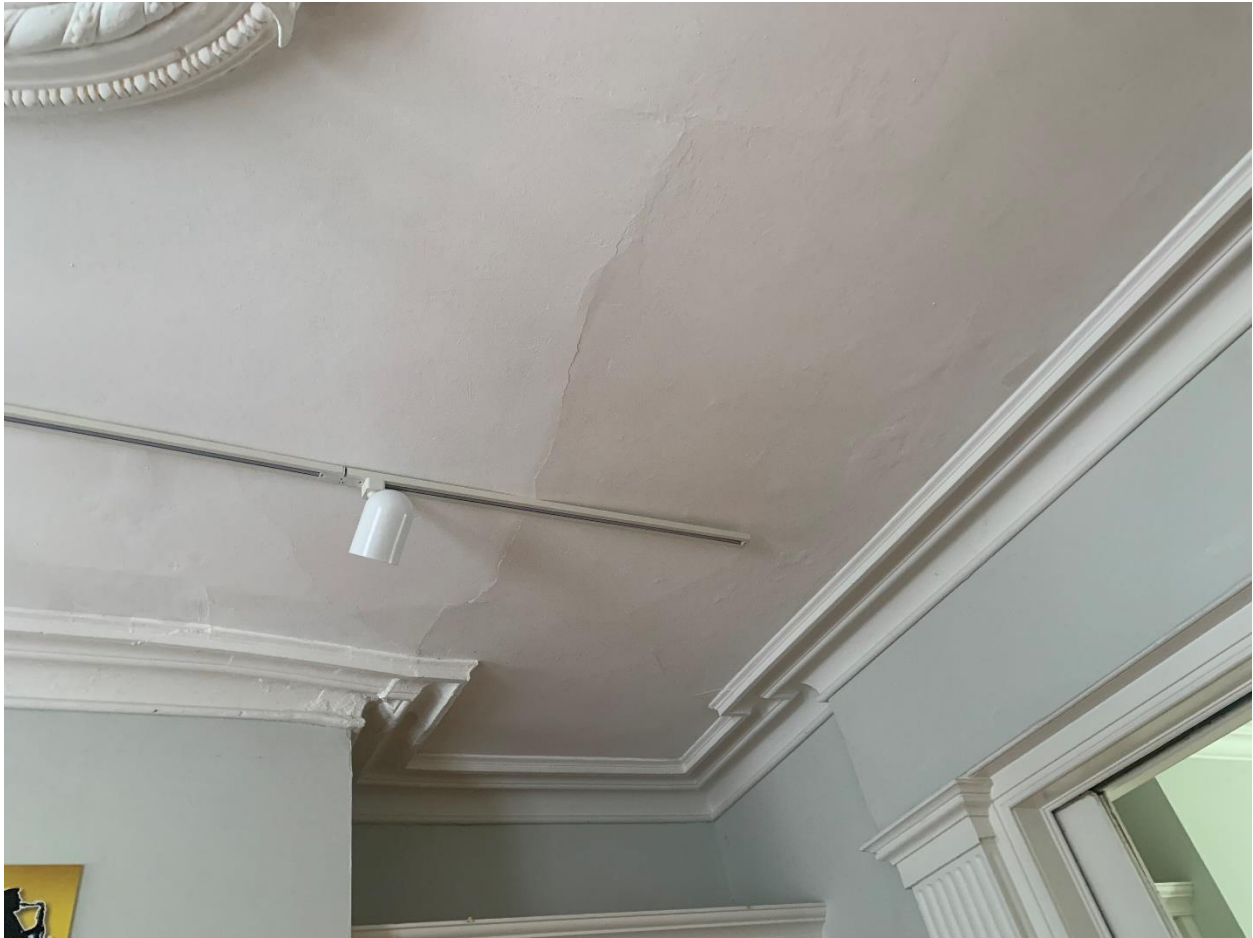
Figure 13. Suite 1A - Cracking/bulging at ceiling

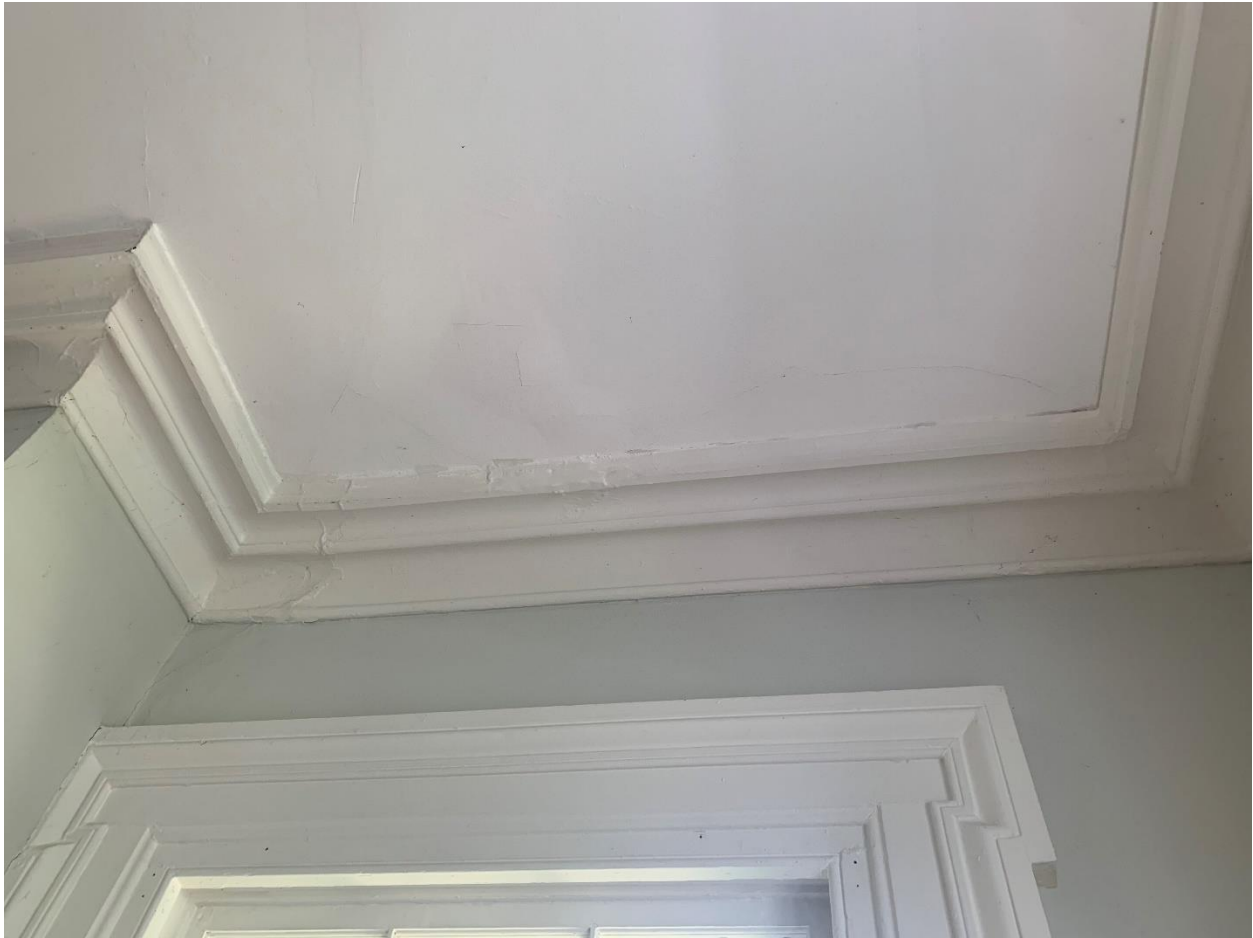
Figure 14. Suite 1A - Apparent water damage and cracking at ceiling located at the first level.

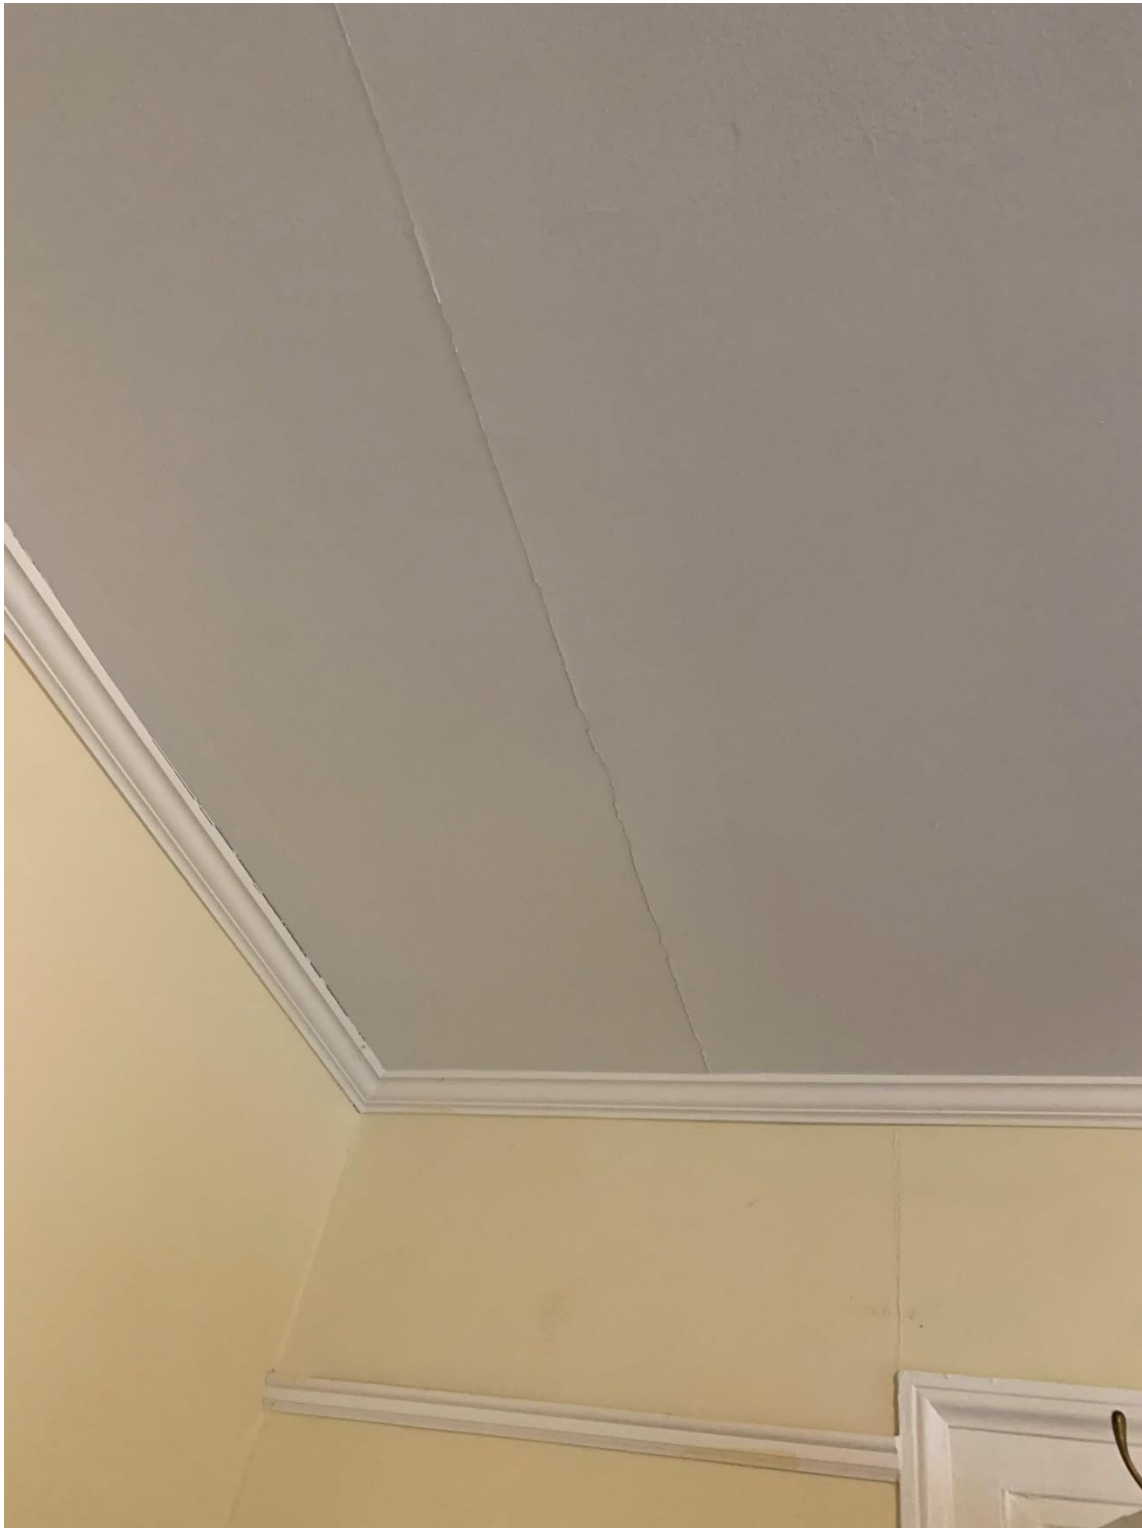
Figure 15. Suite 2B - Cracking of Ceiling Finish at 2nd Floor

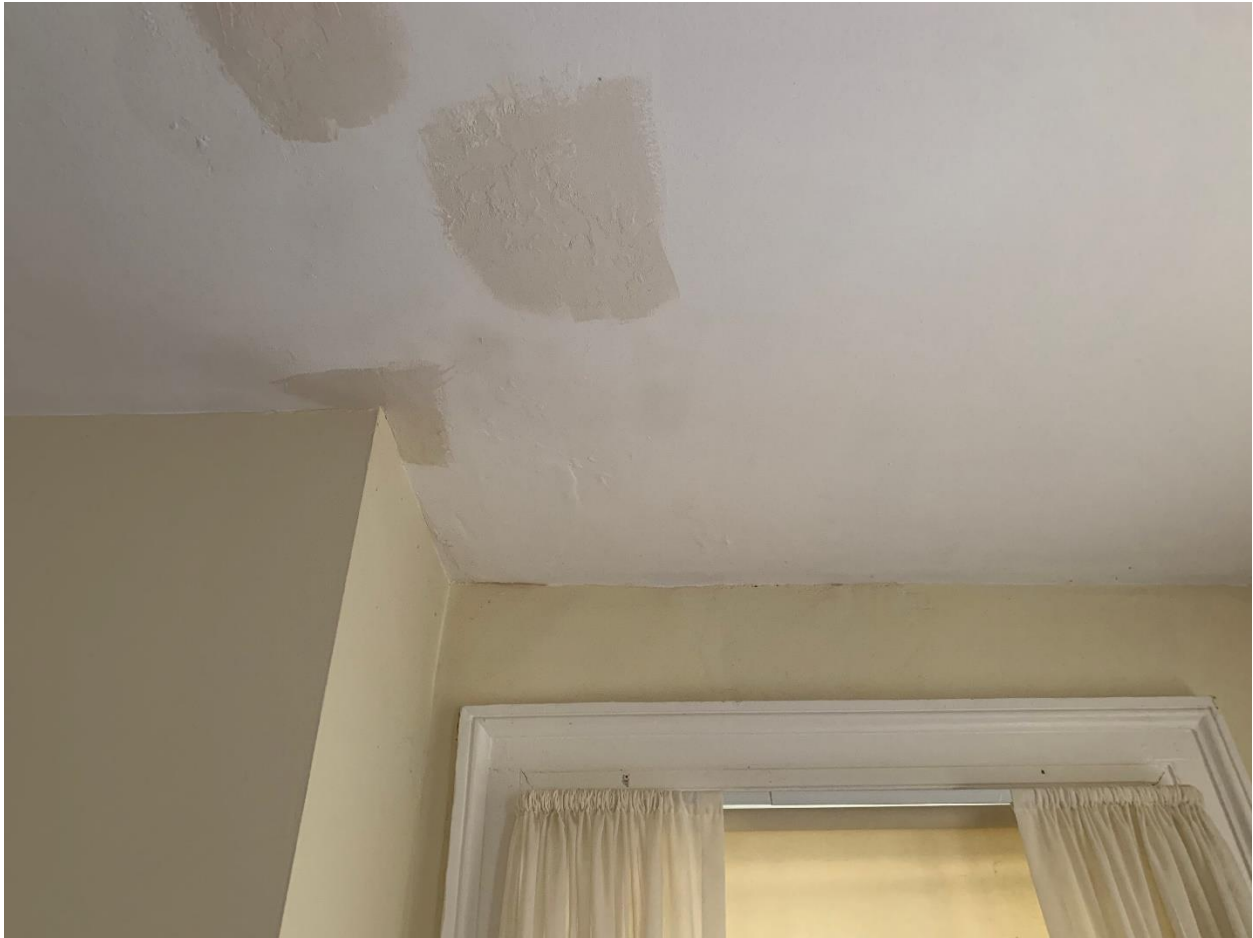
- **2nd floor Finishes:** Wide plank wood flooring is present throughout the 2nd floor tenant spaces which were all found to be in fair condition. Some minor damage to ceiling finishes were noted in tenant spaces '2D' and '2B' (Figure 17, Figure 18, Figure 19, Figure 20).
- **2nd floor bathrooms:** Two bathrooms exist on the 2nd floor (one shared and one private). Both bathrooms appear to have been renovated during the work which was performed in 2005. Both bathrooms are in fair condition.
- **Attic finishes:** Two storage rooms were inspected at the attic level. Within Storage Room 1 signs of a prior leak were noted on the interior walls and floor framing.

Figure 17. Suite 2B - Water damage and staining at ceiling located at the second level.

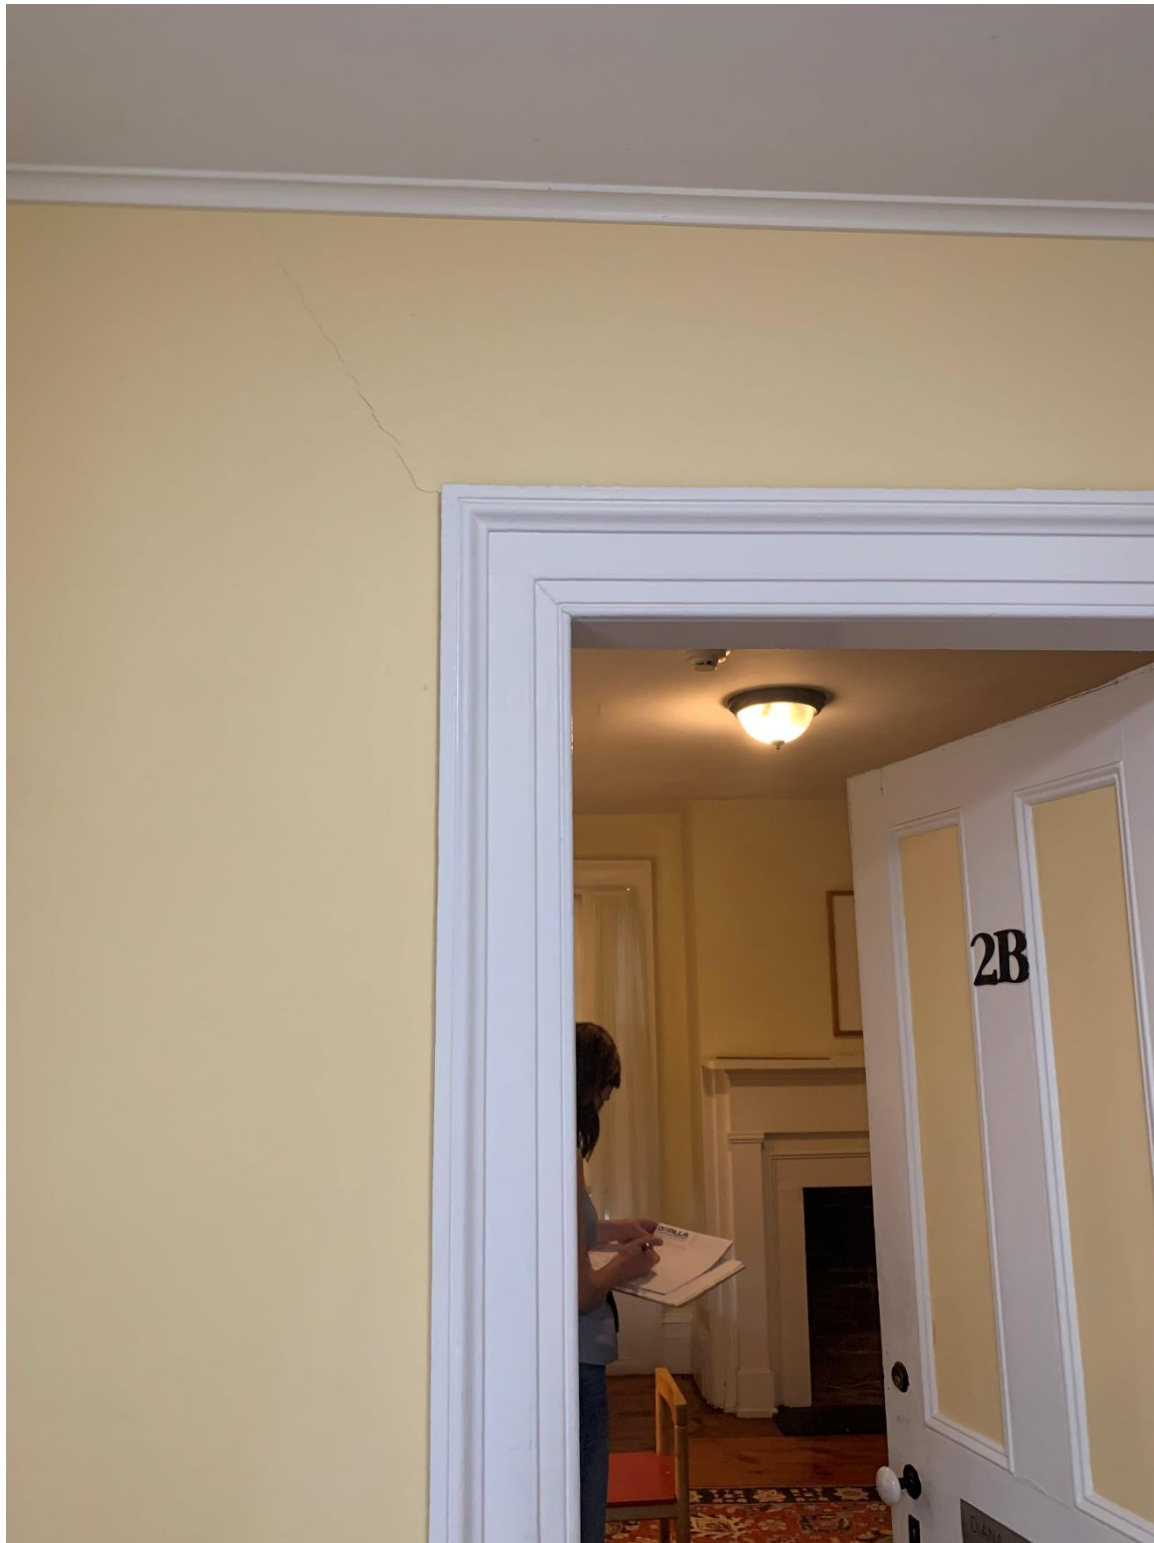
Figure 18. Hallway outside 2B - Cracking at door frame located at the second level.
