EXISTING CONDITION & FEASIBILITY STUDY

**50 PIERMONT AVENUE
NYACK, NY 10960**

September 20, 2024

DRP PROJECT NO

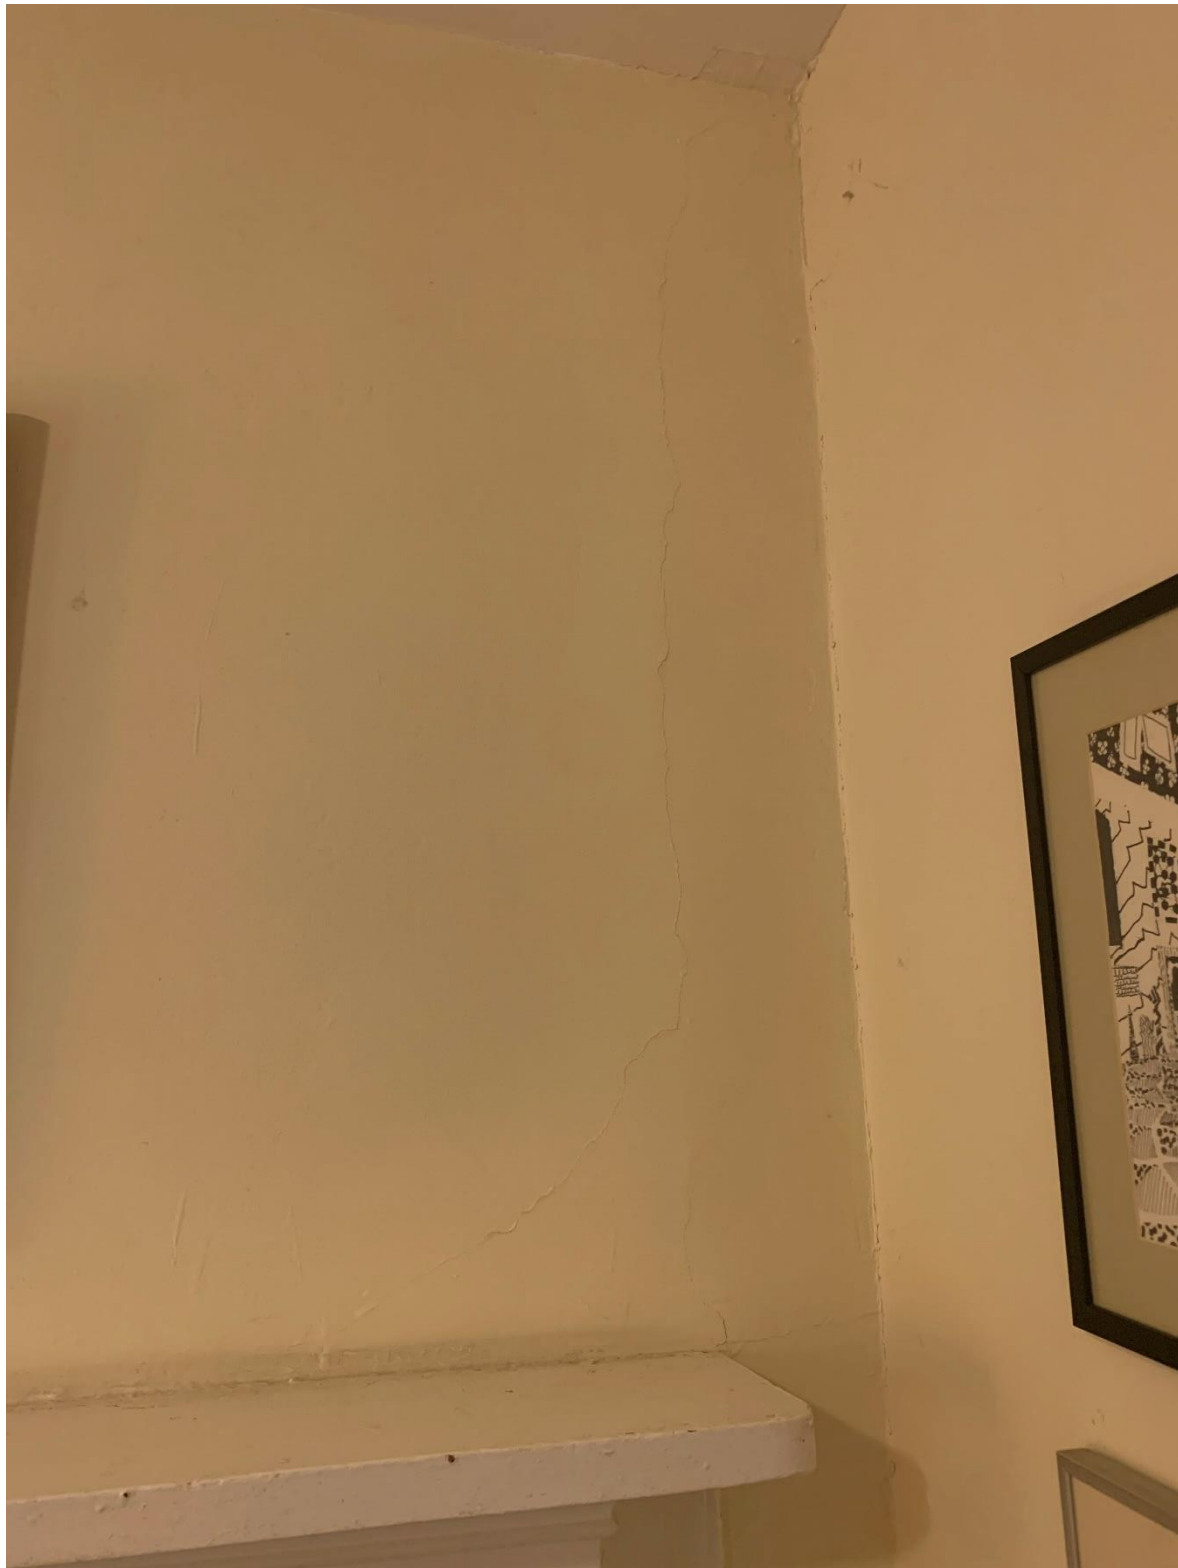
Figure 19. Suite 2B- Cracking along the wall located at the second level.

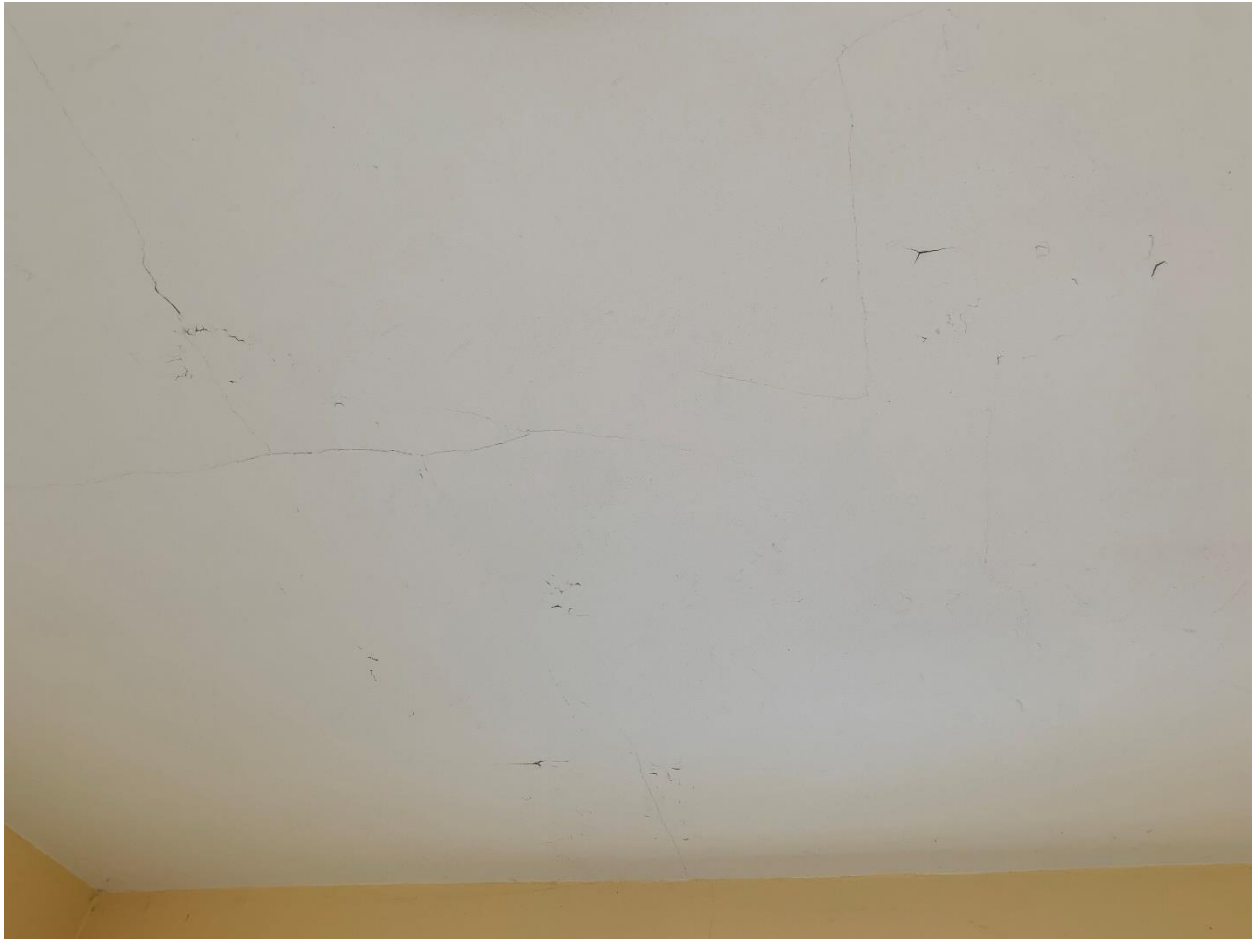
Figure 20. Suite 2D - Cracking at ceiling of 2nd floor

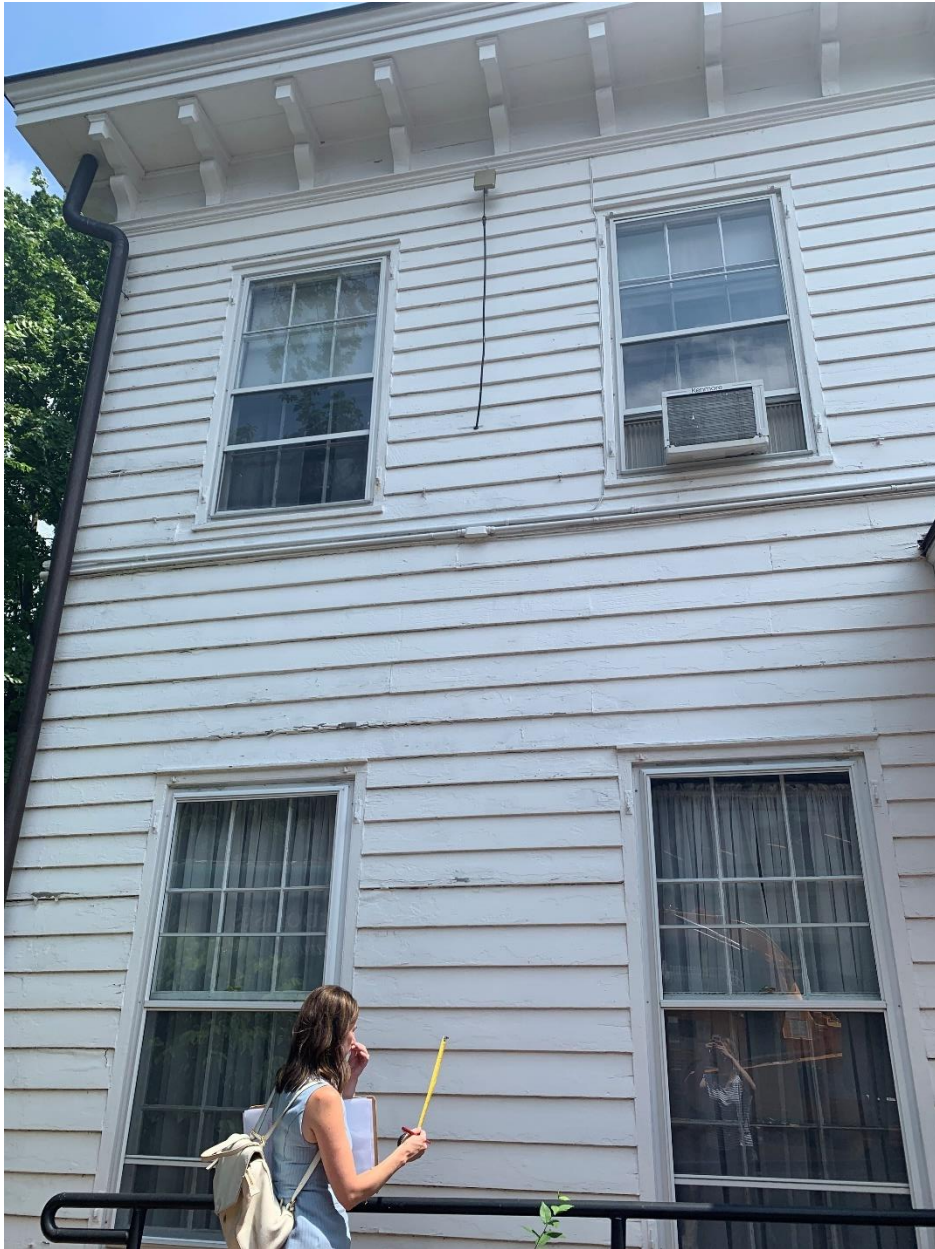
Figure 21. West Façade

- **Wood siding:** Existing siding is in fair condition, with the paint finish beginning to crack and peel in some locations (Figure 21).
- **Windows:** Existing wood windows appear to be original wood windows and appear to be regularly maintained. Most exposed windows have exterior storm windows which provide protection to the original wood windows

- **Wood siding:**
 - All exterior wood components should be repainted due to flaking paint.
- **Windows:**
 - Ongoing maintenance of windows should be performed including scraping and painting to keep windows in fair condition. Exposed wood windows should be repainted approximately every 10 years depending on extent of deterioration.
- **Rear (west) Porch Deck:**
 - Wooden decking should be replaced with new pressure treated lumber for this deck area and all decking repainted to match existing. Damaged portions of trim at the base of the wood posts should be replaced. Ongoing maintenance of all exposed wood elements should be performed to include scraping and repainting as needed.

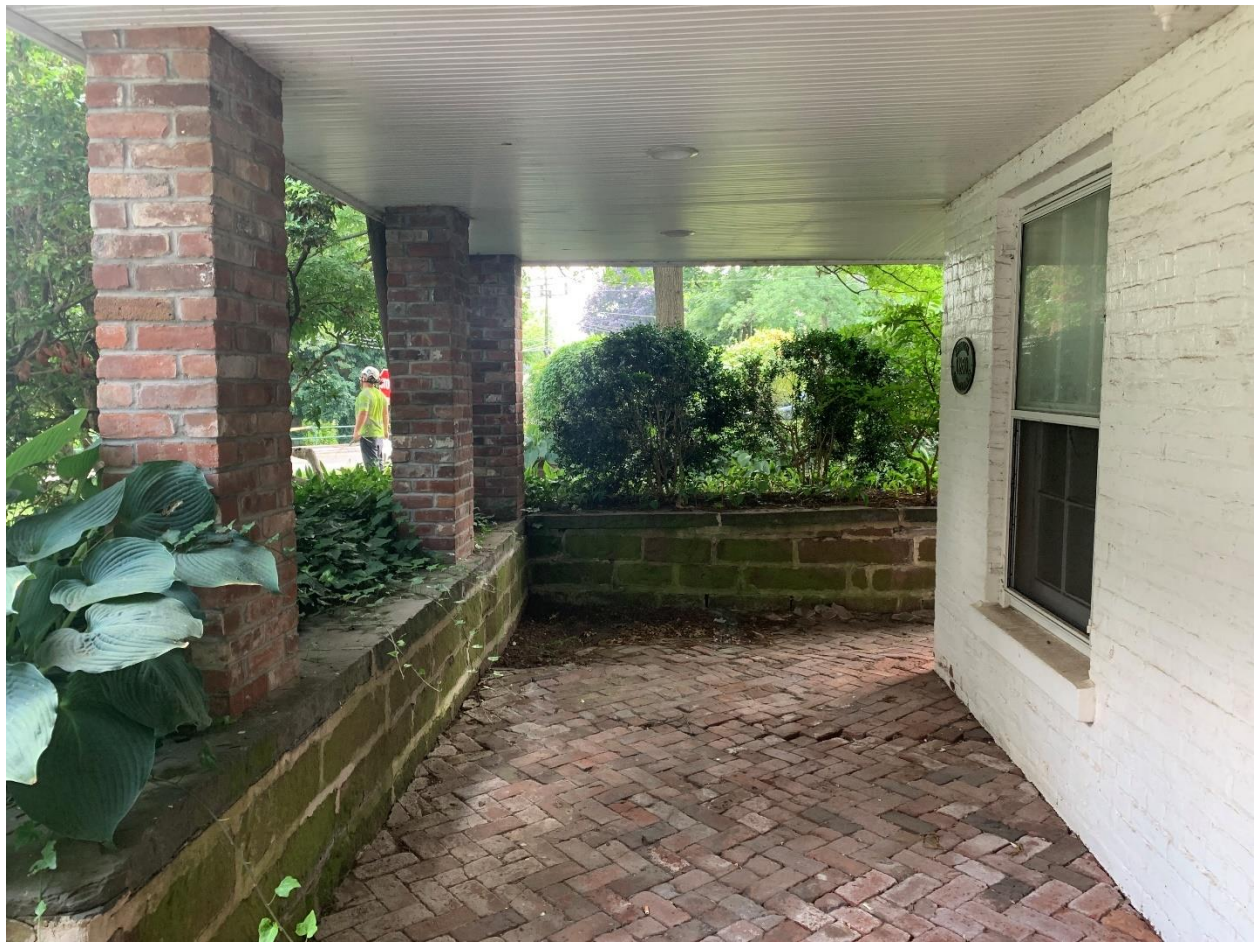
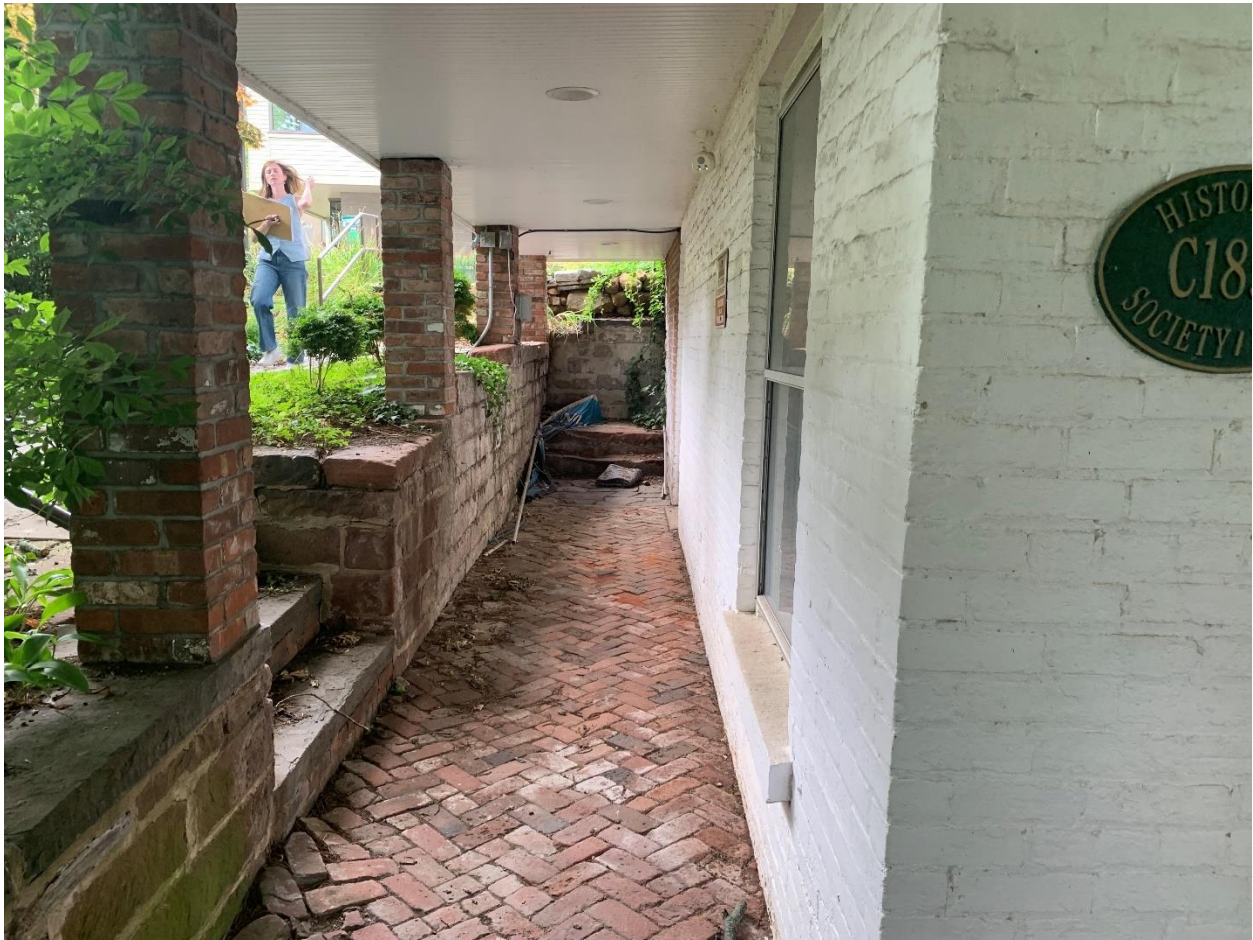
- **Pavers at basement patio:** Brick herringbone paver flooring was found to be in fair condition overall, with some areas of minor heave primarily adjacent to the retaining walls (Figure 22, Figure 23).
- **Stone retaining walls at basement patio:** Portions of the existing stone retaining walls along the south and east sides are bowing (Figure 25).

Figure 22. Condition of Pavers at basement patio

Figure 23. Condition of Pavers at Basement Patio

- **Pavers at basement patio:**
 - Brick paver patio at the basement level should be removed and reset in areas that present a tripping hazard.
- **Stone retaining walls at basement patio:**
 - Soil behind retaining walls should be removed and replaced with gravel wrapped in filter fabric with a French drain at the base. Bowing observed is likely due to a build-up of water pressure behind the stone walls. A French drain should be placed at the base of the gravel to direct water downhill and away from the retaining walls. Any cracks in the mortar joints should be repointed.

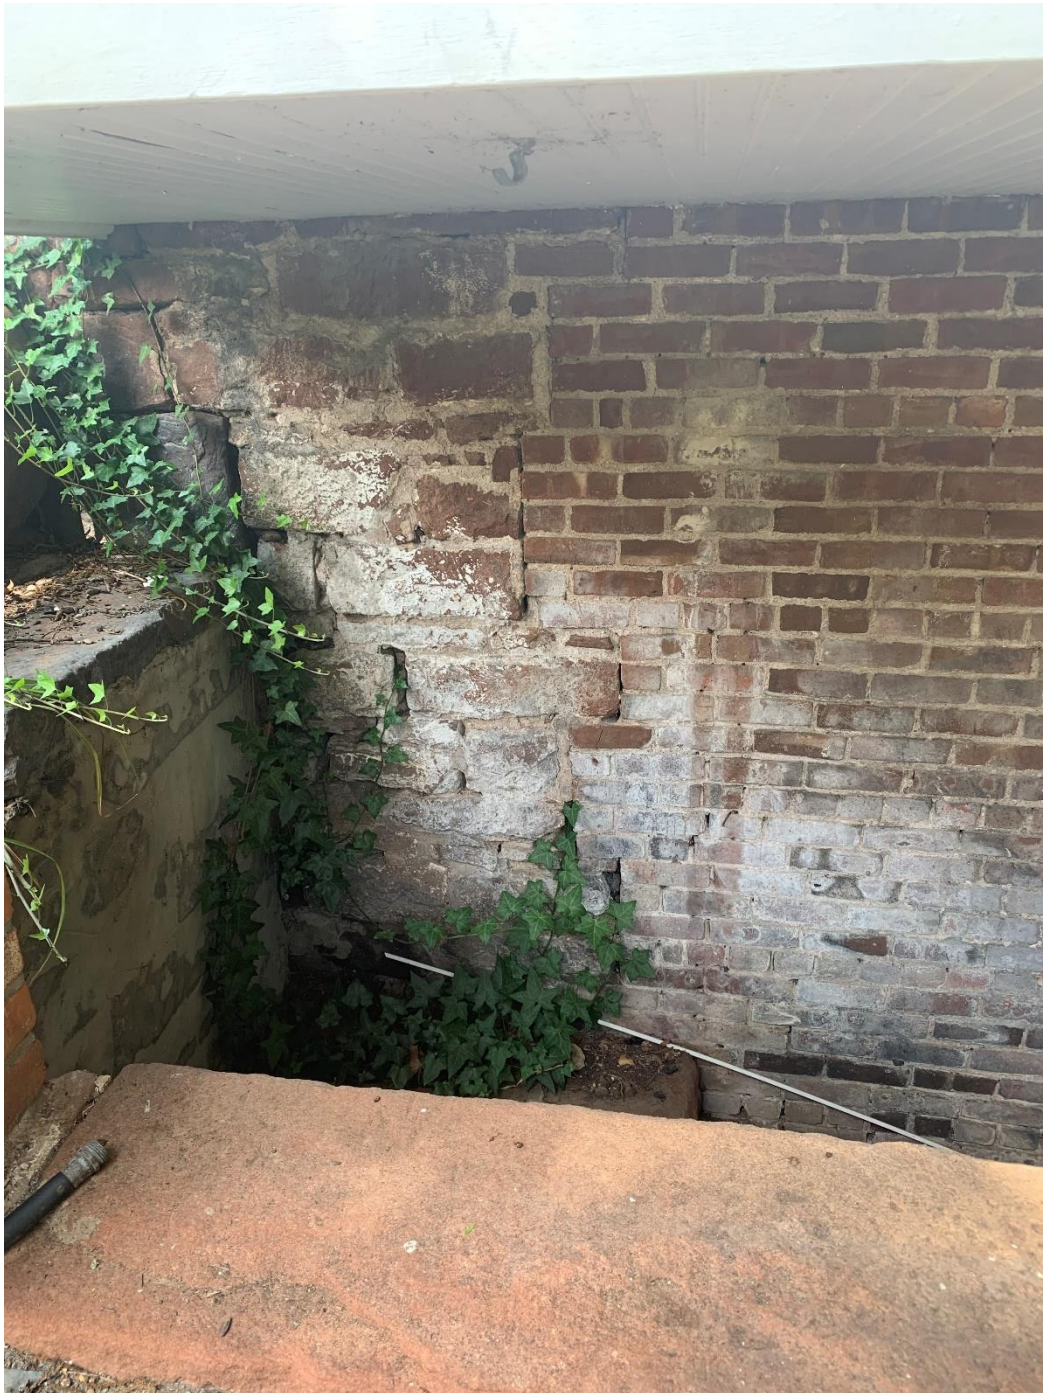
- **Exposed Rubble Foundation Wall:** Existing rubble foundation wall on the southwest corner of the building was found to be in poor condition (Figure 24)

Figure 24. Damaged rubble retaining wall at southwest corner

- **Exposed Rubble Foundation Wall:**
 - Minimally, the existing rubble foundation wall should be repointed. Portions of the wall may need to be rebuilt depending on the extent of the mortar deterioration which would need to be determined at the time the work is performed. .

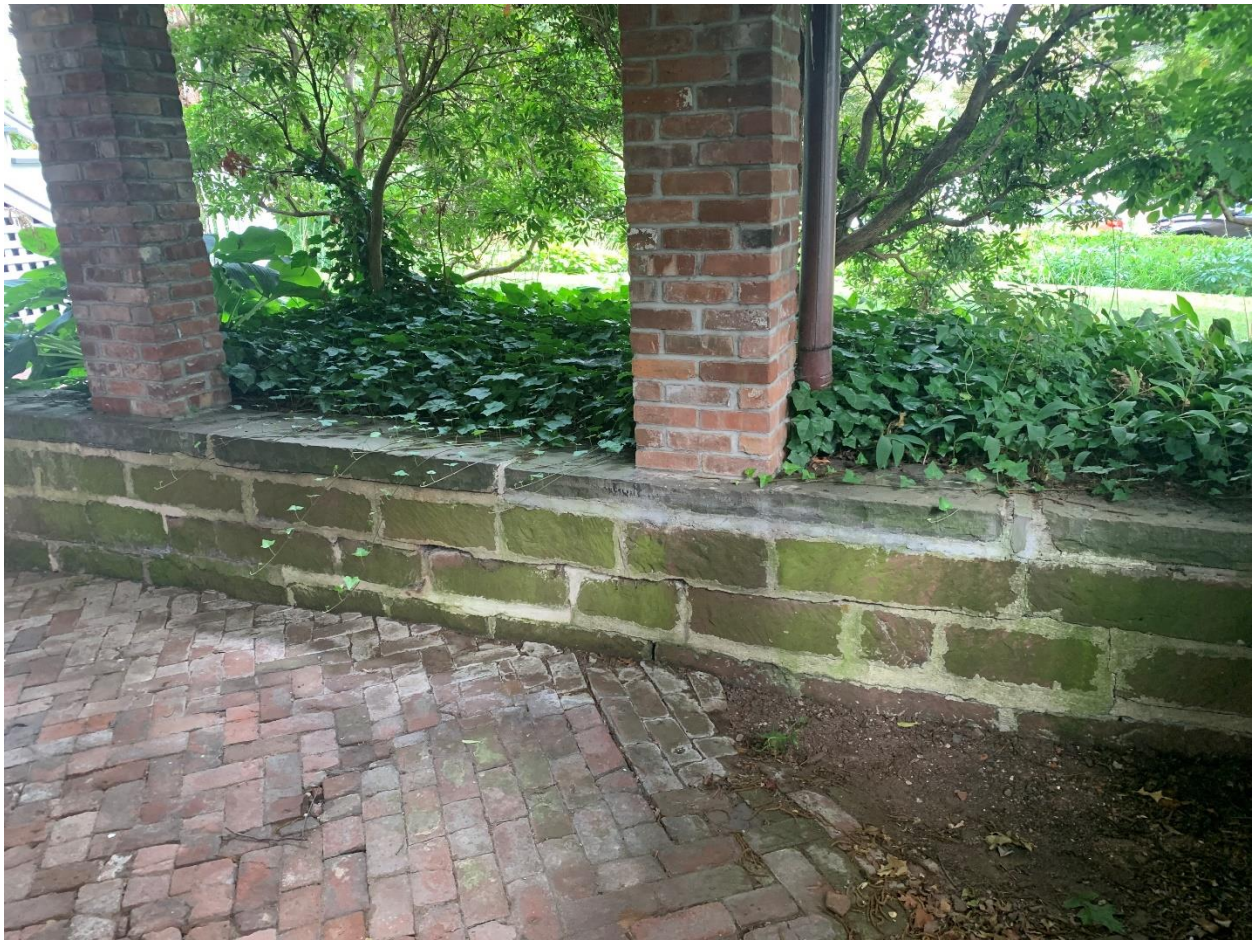
Figure 25. Retaining Wall Condition at basement patio

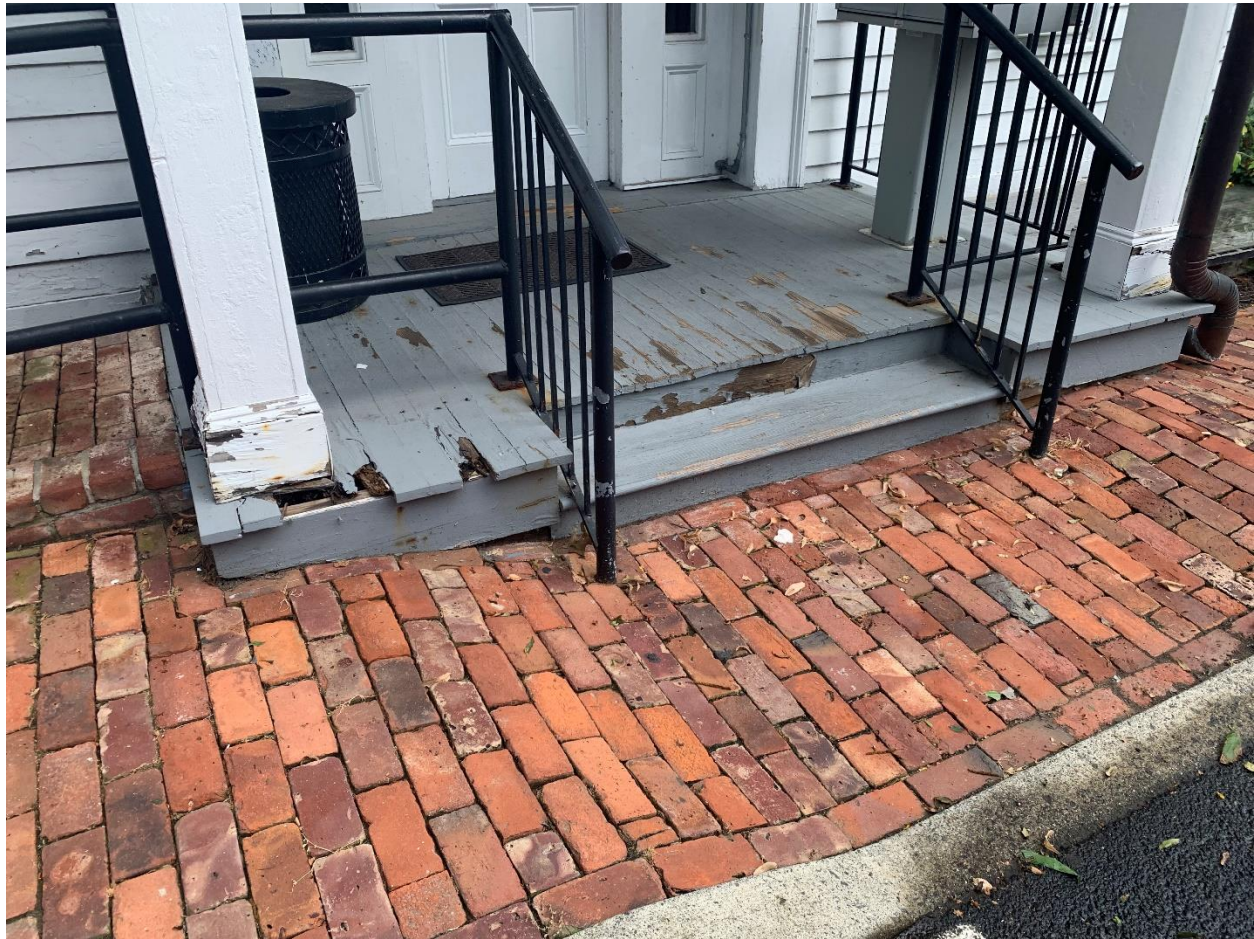
- **Rear (west) Porch Deck:** The rear porch has wood decking for the walking surface which was found to be in poor condition (Figure 26). In addition to deteriorated planking, the trim at the base of the wood columns was found to be in poor condition with flaking paint and some rot at their base. Roof framing, soffit, and all other wooden trim elements appear to be in fair condition.

Figure 26. Damaged wood decking at back entry adjacent to parking lot.

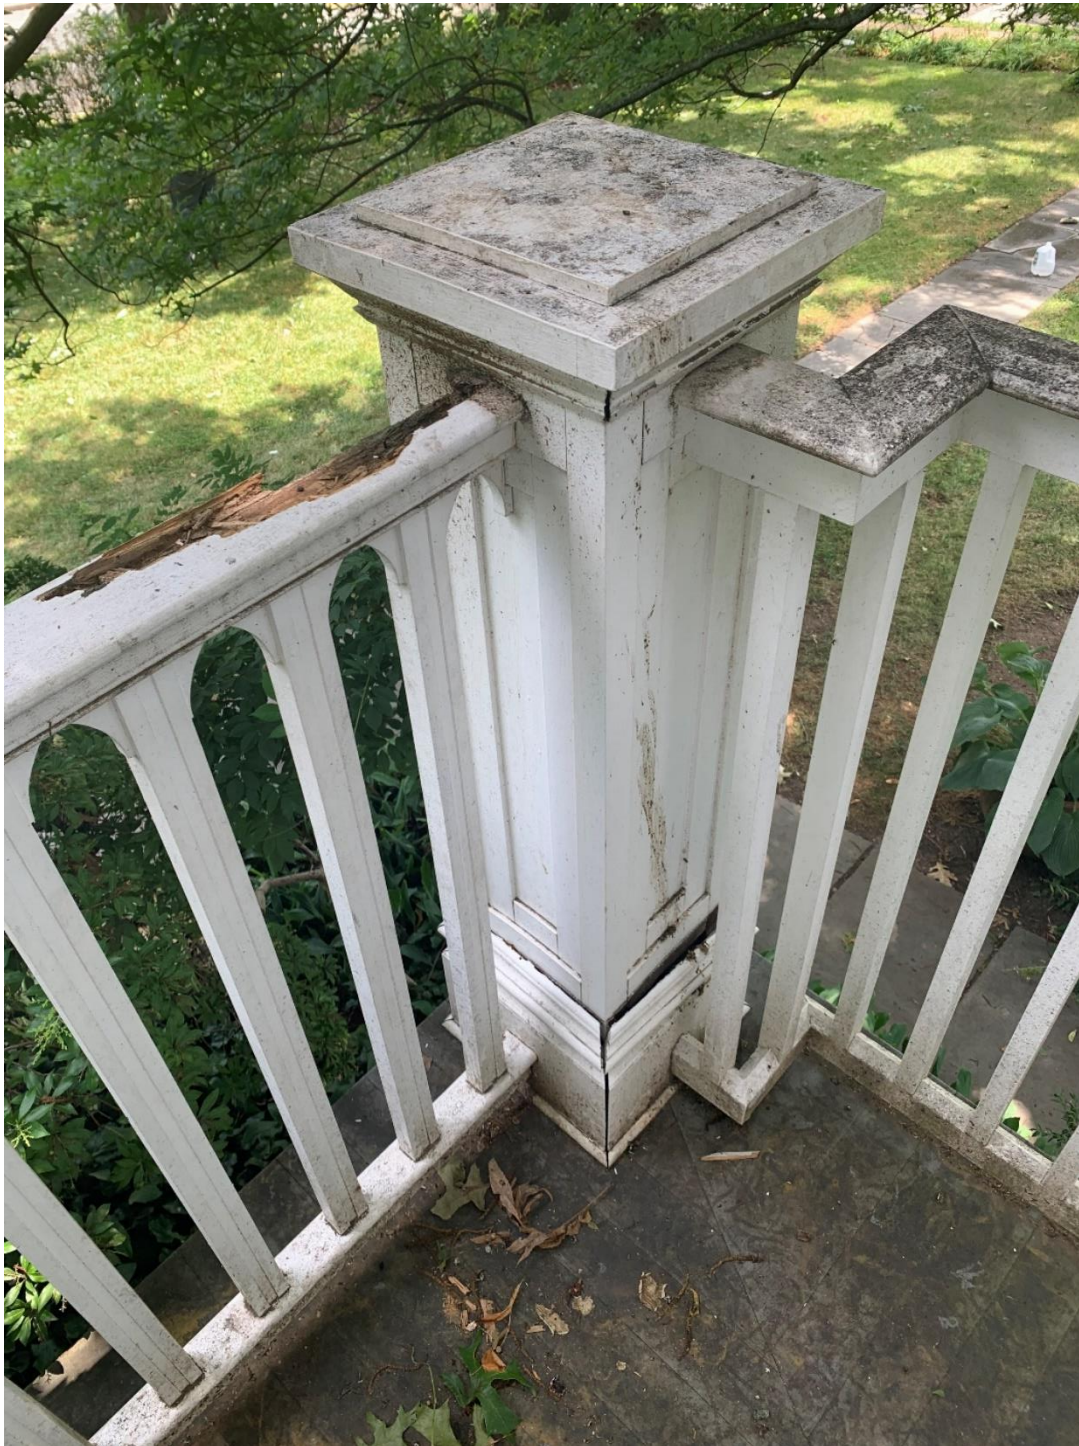
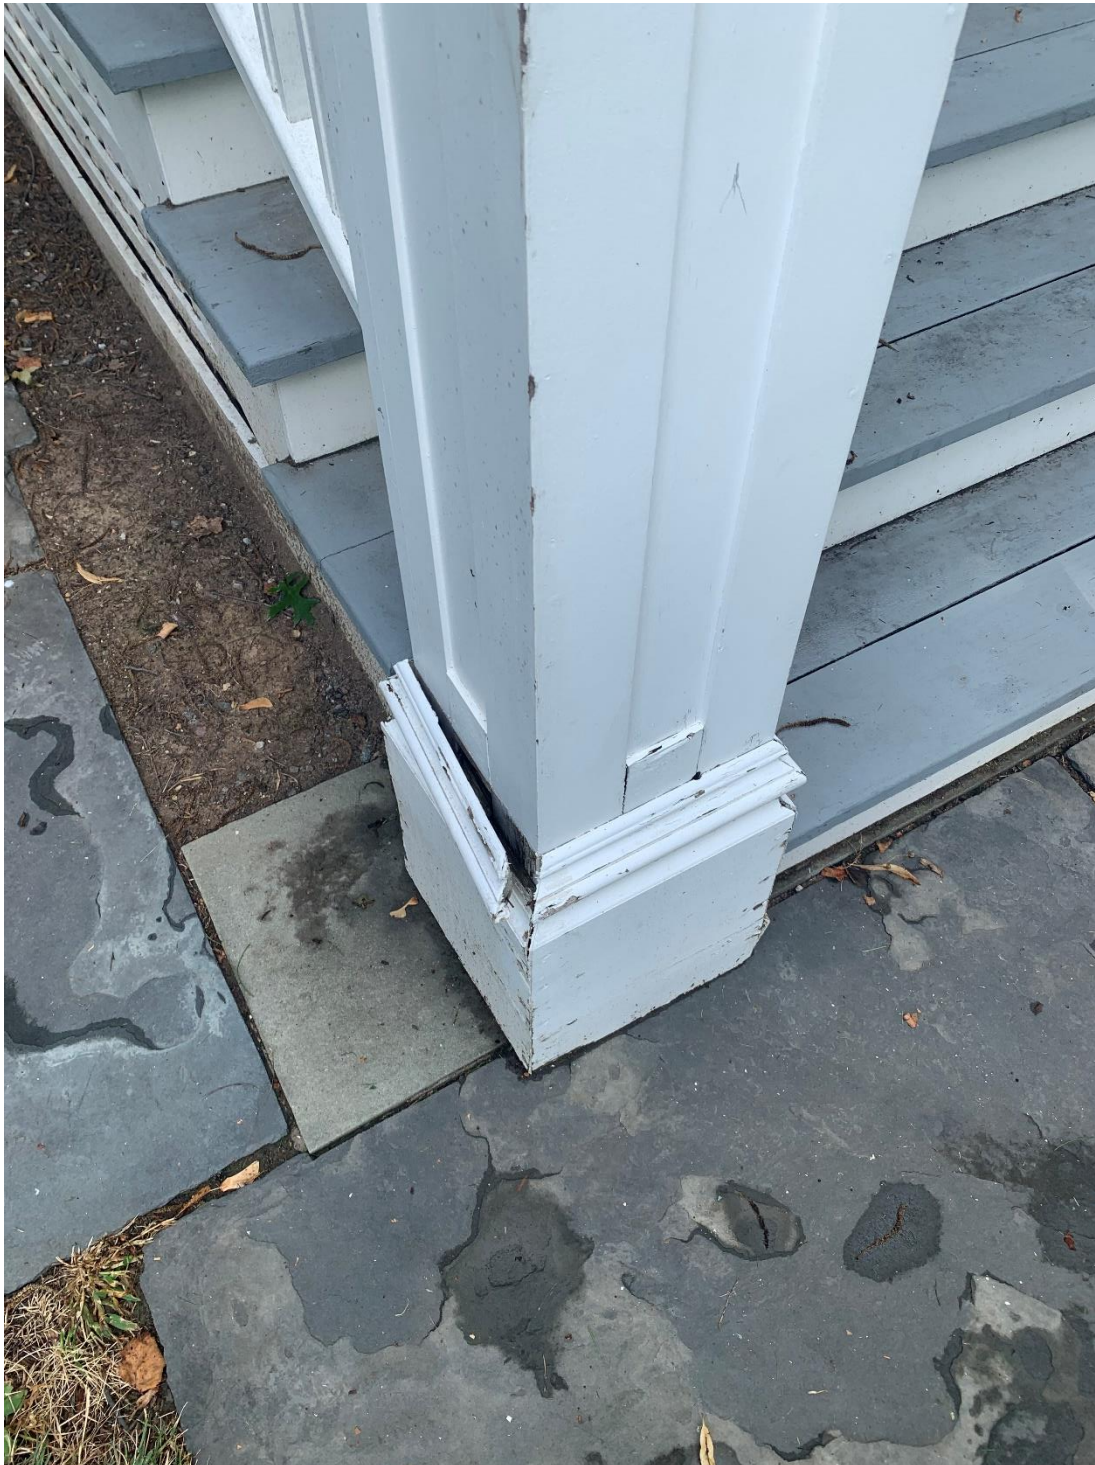
- **Front (east) Porch Deck:** The front porch was found to be in fair condition throughout with some areas of minor damage noted to include damage to railing and railing corner post at the southeast corner of the deck. In addition some minor damage to the trim elements at the base of the entry stair posts were noted. (Figure 27, Figure 28, **Error! Reference source not found.**).

Figure 27. Damaged handrail post at porch.

Figure 28. Damaged base molding of handrail post at bottom of stairs of the front entry.

- **Front (east) Porch Deck:**
 - Portions of damaged trim at handrail posts and damaged portion of handrail at the southeast corner should be replaced in kind with new wooden elements to match existing. All exposed railing and post elements should have ongoing maintenance to include scraping and painting as needed once any chipping of paint finishes are observed.

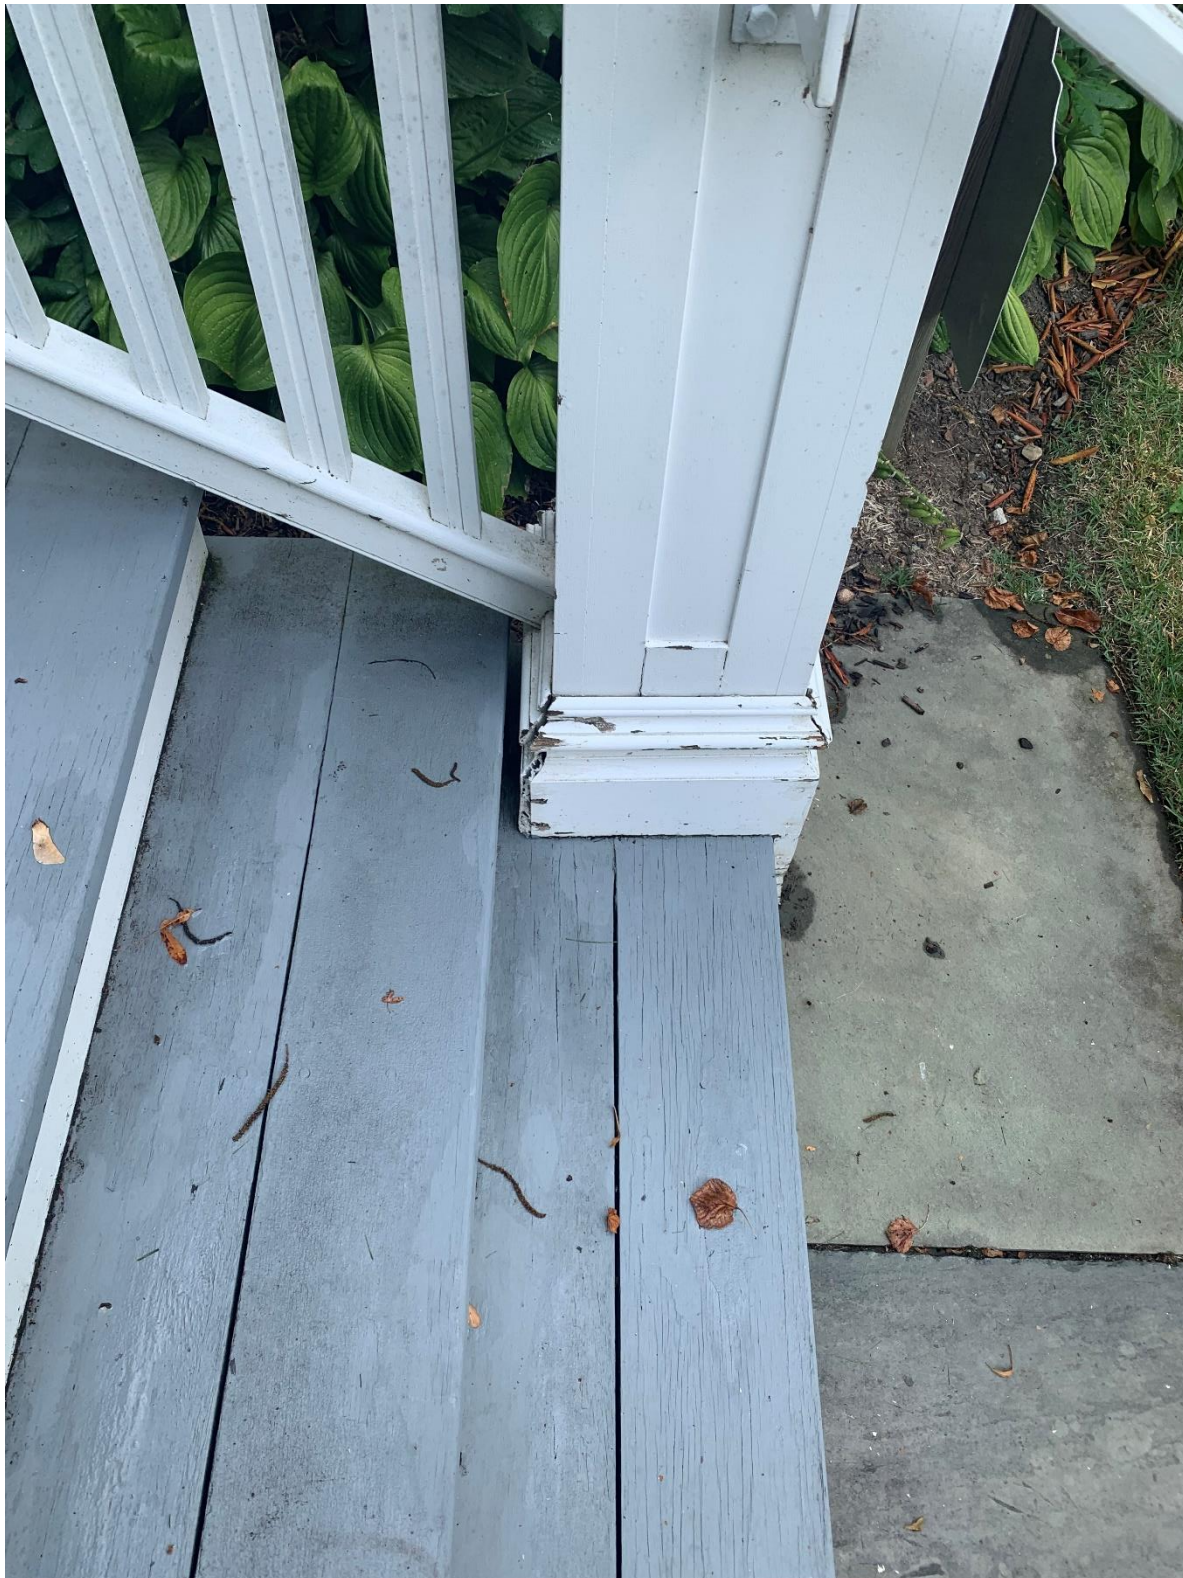
Figure 29. Damaged base molding of handrail post at bottom of stairs of the front entry.
